Urgent Field Safety Notice
Product Correction
Immediate Action Required

Date Issued December 8, 2017

Product Name	List Number	UDI
ARCHITECT c4000 Cuvette Segment	02P75-01	Not applicable
ARCHITECT c8000 Cuvette Segment	01G46-01	Not applicable
ARCHITECT c16000 Cuvette Segment	09D32-05	Not applicable

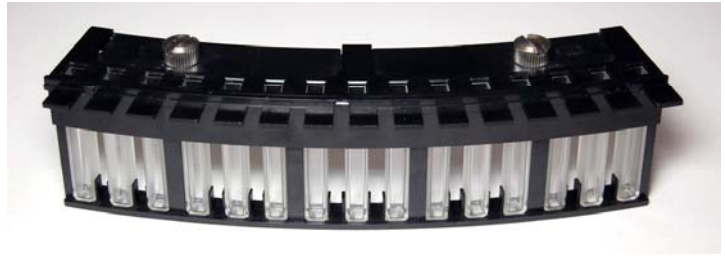
c4000 cuvette segment

The following pictures show examples of normal, undamaged cuvette segments:
