# Urgent Field Safety Notice

## SBN-CPS-2017-005

CPS / Serum Work Area  
Version 2  
01-Jun-2017

### Fretting corrosion on Sample Probe connector may cause sporadic Liquid Level Detection (LLD) failure

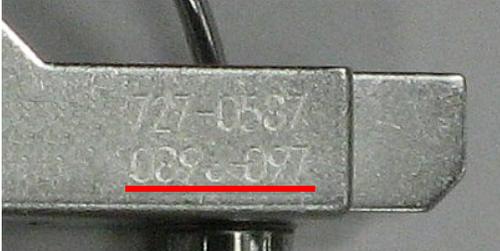
</div> <p>Either <b>NAKA</b> or <b>OMUTA</b> is indicated on the original package.                  Either Black or Green dot is marked on the sample probe.</p> <p>Black dot: Produced by <b>NAKA</b>                  Green dot: Produced by <b>OMUTA</b></p>
Printed place on sample probe	<div style="display: flex; justify-content: space-around;">

</div> <p>Refer to Rule of printed serial number for detail.</p>

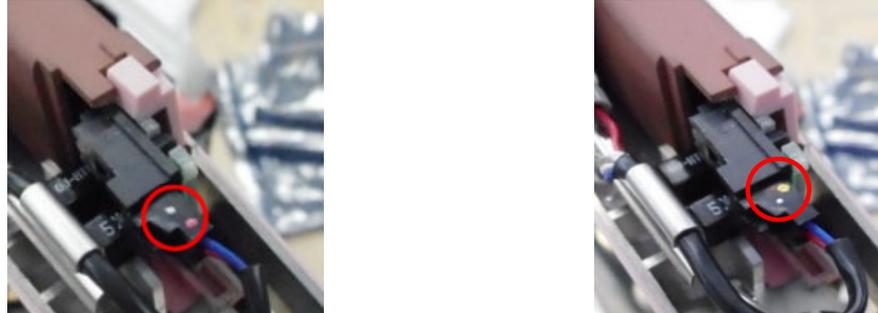
<p><u>No yellow dot mark</u> on the connector is affected.                  If the yellow mark on the connector is existed, the probe was modified done by HHT despite if the Serial number which printed on the probe was met.</p>
<p>SAP lot number which printed on the original package</p>

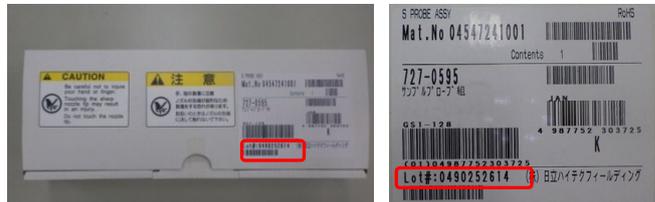
<p>Affected Sample Probe for <b>cobas</b> c311 (P/N 724-0920)</p>	<p>Lot number which indicated on the logistics label</p> <p>0490232027, 0490233855, 0490236427, 0490238543, 0490241937, 0490248322, 0490250880, 0490235713, 0490252029,                  0490256963 (not affected),                  0490254335 (new)</p>

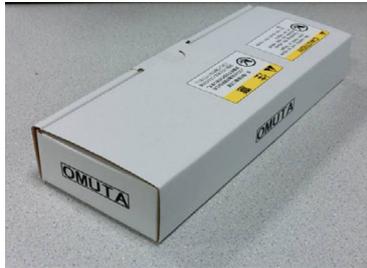
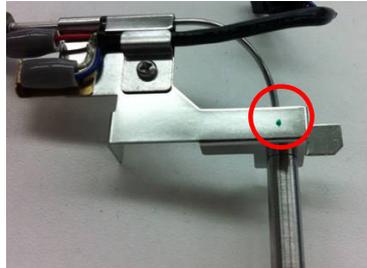
</div> <p>Either <b>NAKA</b> or <b>OMUTA</b> is indicated on the original package.                  Either Black or Green dot is marked on the sample probe.</p> <p>Black dot : Produced by <b>NAKA</b>                  Green dot : Produced by <b>OMUTA</b></p>
<p>Place of yellow dot on the connector</p>	<div style="display: flex; justify-content: space-around;">

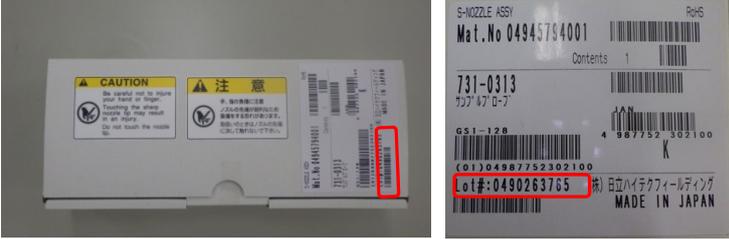
<p>SAP lot number which printed on the original package</p>

<p>Refer to the separate attachment for detail of SAP lot numbers which printed on the original package.</p>
<p>Affected Sample Probe for <b>cobas</b> c701/<b>cobas</b> c702 (P/N 731-0313)</p>	<p>0490238960, 0490238961, 0490238961, 0490238961, 0490238963, 0490242332, 0490251040, 0490251041, 0490252546, 0490252547, 0490252547, 0490254810, 0490254811, 0490221658, 0490223228, 0490223229, 0490225255, 0490226172, 0490226173, 0490226174, 0490227626, 0490227627, 0490227628, 0490230276, 0490230277, 0490230279, 0490232203, 0490232204, 0490232205, 0490232206, 0490233778, 0490233779, 0490233780, 0490233781, 0490233783, 0490235909, 0490235910, 0490235911, 0490235912, 0490235913, 0490237365, 0490237366, 0490237367, 0490237368, 0490237369, 0490237370, 0490238901, 0490238902, 0490238903, 0490238904, 0490242160, 0490242161, 0490242163, 0490242165, 0490242166, 0490250498, 0490250499, 0490250500, 0490250501, 0490250502, 0490252308, 0490252312, 0490252318, 0490252320, 0490252322, 0490254558, 0490254559, 0490254560, 0490254561, 0490254562, 0490257035, 0490257036, 0490257037, 0490257038, 0490257039, 0490257854, 0490257855, 0490257856, 0490257857, 0490257858</p>
