IMPORTANT MEDICAL DEVICE ADVISORY

HeartMate 3™ Left Ventricular Assist System Catalog # 106524INT – HM3 LVAS KIT

April 5th, 2018

Description of Outflow Graft Twisting in HeartMate 3 LVAS

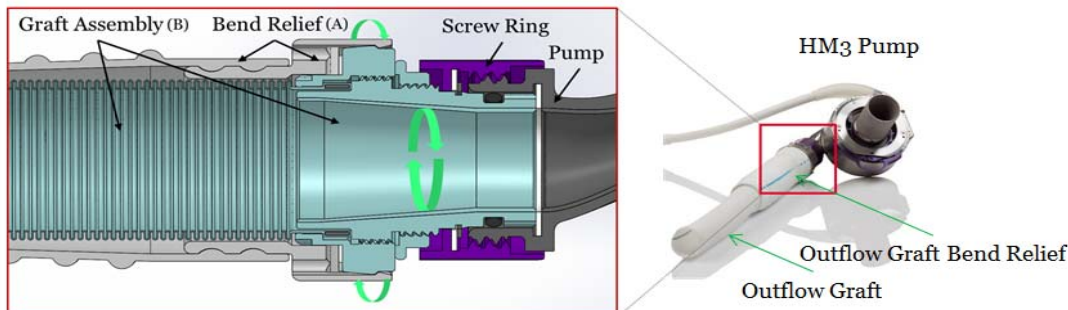
The Outflow Graft is the conduit for blood flow from the HM3 pump to the ascending Aorta.

Normal *in vivo* forces associated with heart beats, respiration and patient activity can cause small rotations between the Outflow Graft Bend Relief (A) and the pump. These rotations are expected and appear to be 'back and forth' without accumulation in either direction. However, there is the potential for these forces to be preferentially translated to the outflow graft (B) in either the 'back' or 'forth' direction which may deform the outflow graft and reduce pump flow. The accumulation of outflow graft twist can occur at any point beyond implant. Postoperative twisting and occlusion of the HM3 outflow graft may result in the need for surgical intervention following the original implant procedure.

- During implant, when attaching the Outflow Graft to the Pump Cover, a clicking sound will be heard as the Screw Ring is tightened. Continue turning the Screw Ring clockwise until it comes to a complete stop and stops clicking for a firm hand tightened connection.
- If a low flow alarm persists at any time following implant, and other potential causes such as hypertension, low preload, right-heart failure and inflow occlusion have been considered for cause, a Computed Tomography (CT) angiography should be taken to identify the possibility of an outflow graft twist occlusion.
- In the event surgical repair of the outflow graft is needed due to a twist occlusion, the Outflow Graft Bend Relief should be reattached in its original state or repaired to prevent further kinking or occlusion of the graft.
