Urgent safety information

Safety information regarding the affected products of the Aurinio L 110, L 120, L 150 and L 160, Aurinio OR lights series

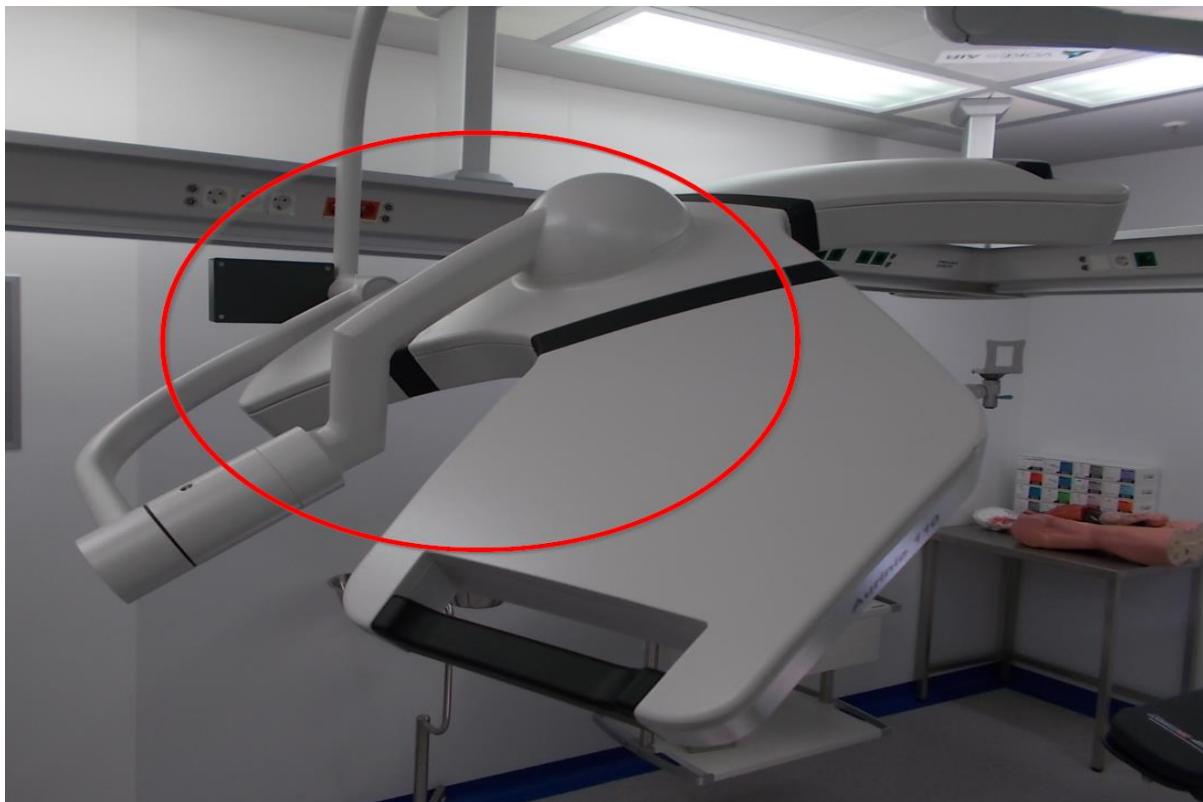
Figure 1: Overall system of the Aurinio OR light – affected component marked

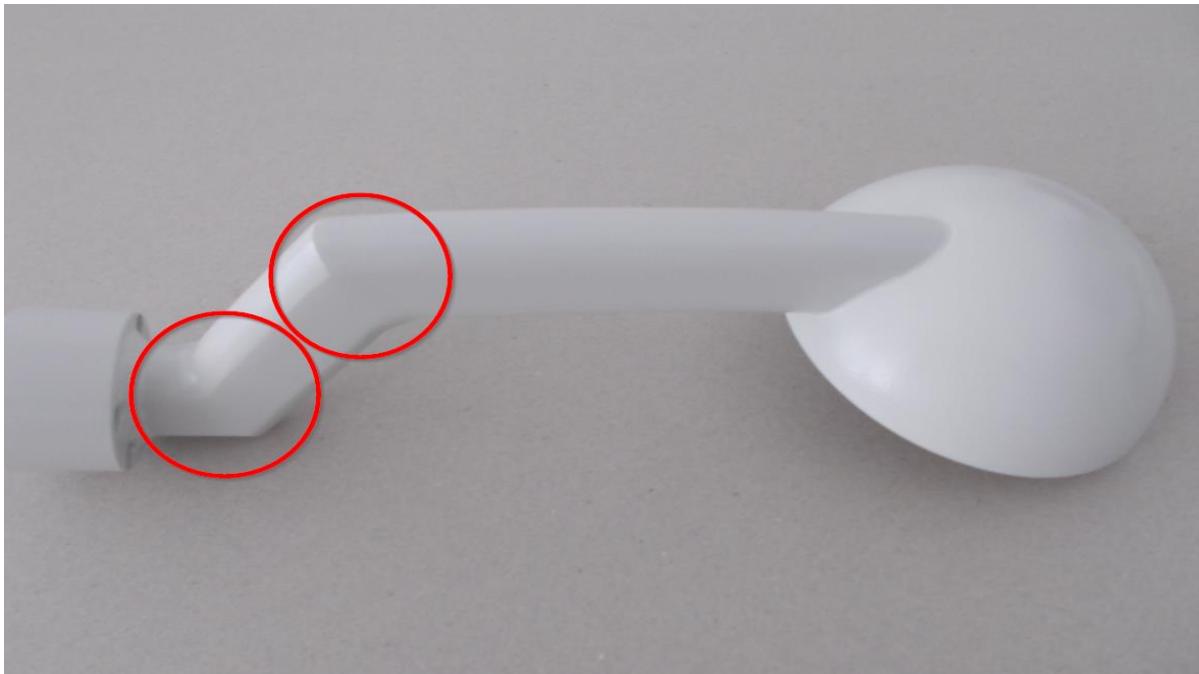
In the context of our worldwide product monitoring, we have determined that a formation of tears can occur in the support structure of the aforementioned lights. This results in a situation where the load-bearing capacity may potentially no longer be ensured and may lead to a material breakage at the welding seam of a component of our OR lights.

Figure 2: Light's connection – potentially affected areas

Until the corrective measure has been carried out, the affected component (light's connection) of the Aurinio OR light must be subjected to a daily visual inspection for a potential tear formation, in accordance with the marked areas of Figure 2.

In this inspection, please bear in mind that the inspection for the formation of tears must be carried out all around.

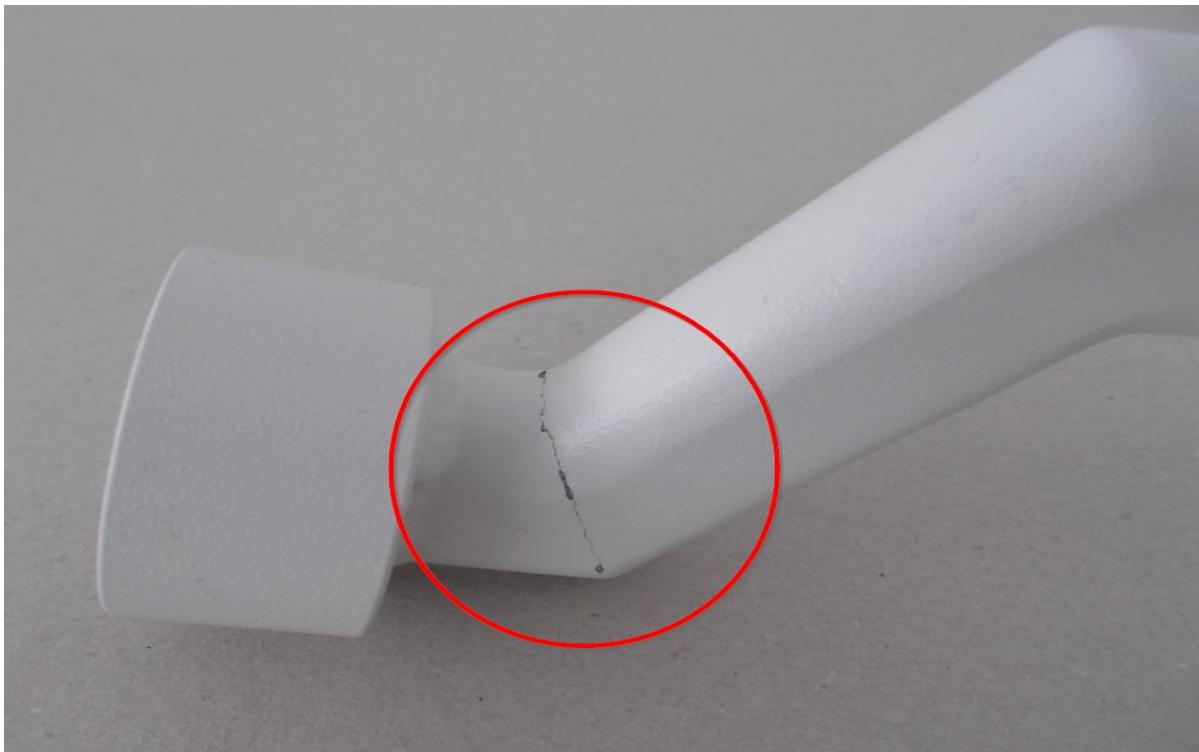
paint on the surface. This can be checked via a visual inspection. The gap that occurs is increasing slowly.

The following figure shows the affected component (light's connection) with the formation of tears to be potentially observed.

Figure 3: Light's connection – tear observable
