IMPORTANT FIELD SAFETY NOTIFICATION

Subject: Potential for the iViewGT™ and XVI detector arms to extend due to gravity

Product: Digital Accelerator

Notification Released: December 2017

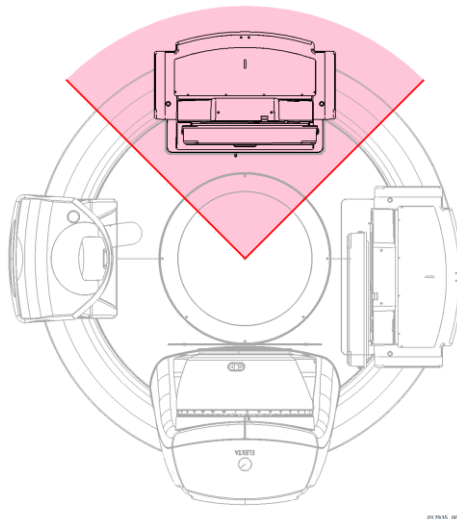
Elekta has identified that if the microswitch within the middle arm is not set up correctly, it is possible for the MV or kV detector arm to extend due to gravity.

- The microswitch (within the Solenoid Limit Switch of the PCB assembly in the middle arm) is activated incorrectly.
- The detector-locked solenoid is not fully engaged in the interface bracket.

The detector arm is opened or closed above the patient, when the gantry angle is at 180° ($\pm 45^\circ$).

Figure 1 – Not recommended open and close positions of the MV detector arm

Elekta recommends that the user does not open or close the detector arm when it is positioned above the patient, as specified in the Instructions For Use (IFU).

Elekta Field Service Representatives will do checks to make sure that that the microswitch activates only when the detector-locked solenoid is fully engaged in the interface bracket.

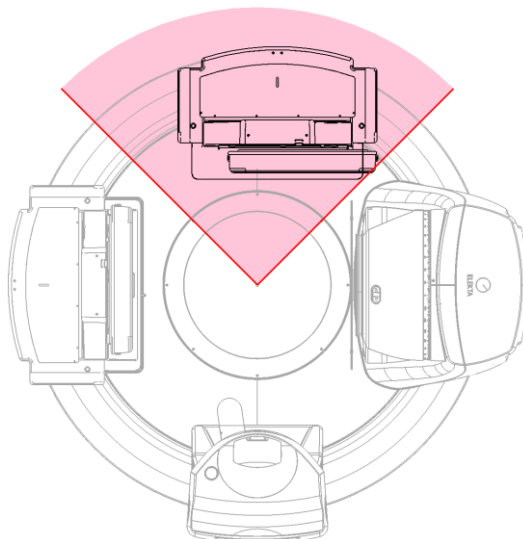
017936_001

The detector arm is opened or closed above the patient, when the gantry angle is at $90^\circ (\pm 45^\circ)$.

Figure 2 – Not recommended open or close position of the kV detector arm.
