Urgent Field Safety Notice

SynchroMed® II Implantable Drug Infusion Pump

Design Change of Model Numbers 8637-20 and 8637-40

Medtronic reference: FA794

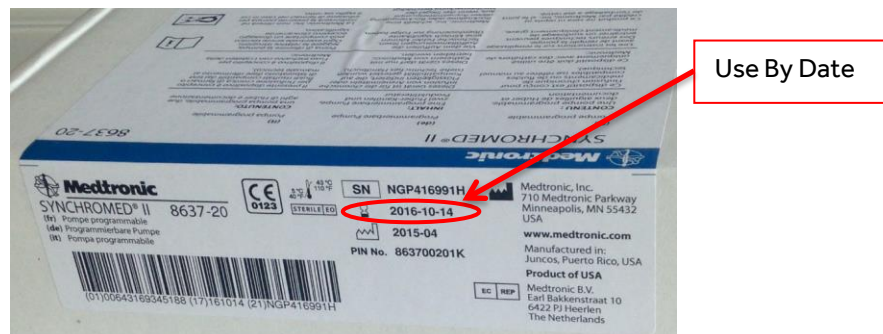
Pump Identification: in Europe, Middle East, Africa, Latin America and India any pump with a Use By date **on or before** 2018-12-31 was manufactured **prior to** design change. An image of the Shelf Box Side Label of the SynchroMed II is shown below.
