Urgent Field Safety Notice

SBN-CPS-2017-015

cobas c 501/502 operator injury on USM cover 3

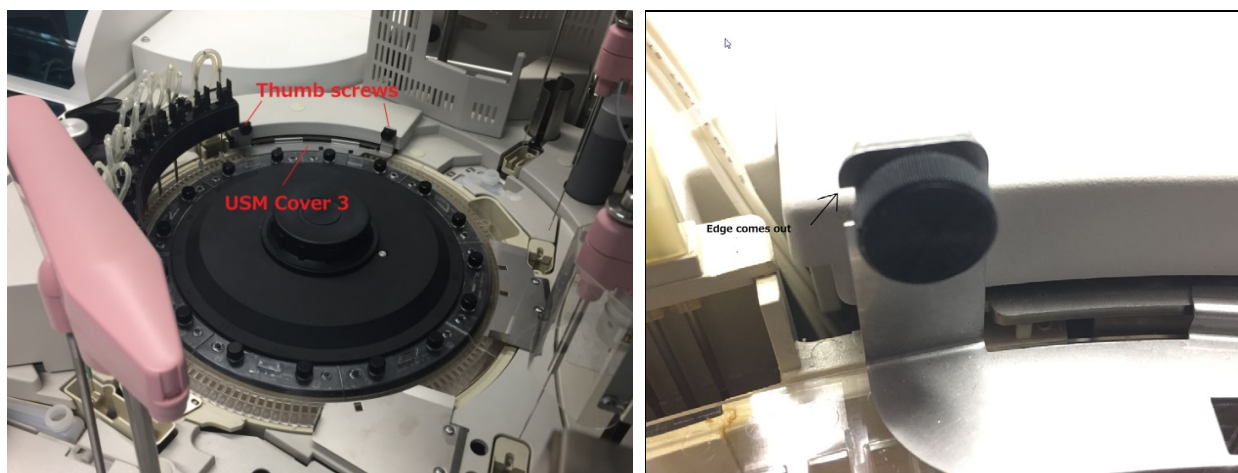
1. The operator was performing monthly maintenance to clean the incubation bath and replace cuvettes on a **cobas c** 502 module.
2. As a preparation step, thumb screws were being loosened to remove the USM cover 3, as illustrated below.
3. When the operator gripped the left thumb screw and tried to loosen it, she felt pain on her left thumb and found that it was already bleeding.
4. Her thumb was injured by the 90 degree-edge of the USM Cover 3, which is shown on the following picture.

Although the sharp edge of the USM Cover 3 is clearly visible, a medical risk due to an injury cannot be excluded.

A warning will be added to the respective Operator Manuals, which will be available by December 2017.

Customers are advised not to overtighten the thumb screws when replacing the cover after maintenance. When removing the screws for maintenance **avoid** touching the edge of the USM Cover 3.
