**Urgent – Field Safety Notice**  
**Diagnostic X-ray system GC80, GC85, GC70**

***Infrared Ray (IR) sensor applied to the bottom of the table and  
Software upgrade***

This response form is to confirm receipt of the enclosed Samsung Electronics Field Safety Notice (FSN- GC\_180530-1). Please read the Field Safety Notice and indicate the appropriate answers to the questions below.

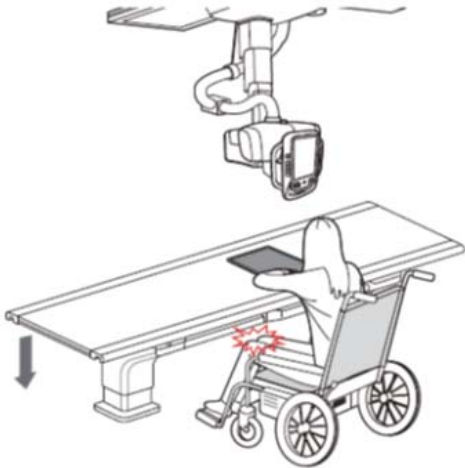
<p><b>Affected products</b></p>	<p>Samsung Digital X-ray system GC80, GC85, GC70</p>
<p><b>Description of the problem</b></p>	<p>1. The patient's lower body could be pressed by the table when it's moving automatically down.</p>

<p><b>Corrective actions taken by Samsung</b></p>	<p>To prevent such issues, Samsung has prepared IR sensors which would be attached to the bottom of the table and also prepared an upgraded software package.</p>

<p>1. After the IR sensor applied to the bottom of the table, if a patient body is under the table board when using the automatic movement features, the IR sensor does not allow the table to move downward.</p> <p>2. This software includes the removal of unnecessary processes that cause the problem. Therefore, after the software upgrade, the problem will not happen again.</p> <p>A service Engineer will contact you as soon as possible to apply all of this package.</p>
<b>Support contacts</b>	If you need any further information, or have any concerns, please contact your local Samsung representative.
