Cressier, 2018 July 11

Urgent: Field Safety Notice / FSCA 004-18

Product name	Reference number	Versions
IH-Com Fullversion	009000	5.1.7 and 5.1.10
IH-Com for Reader	009010

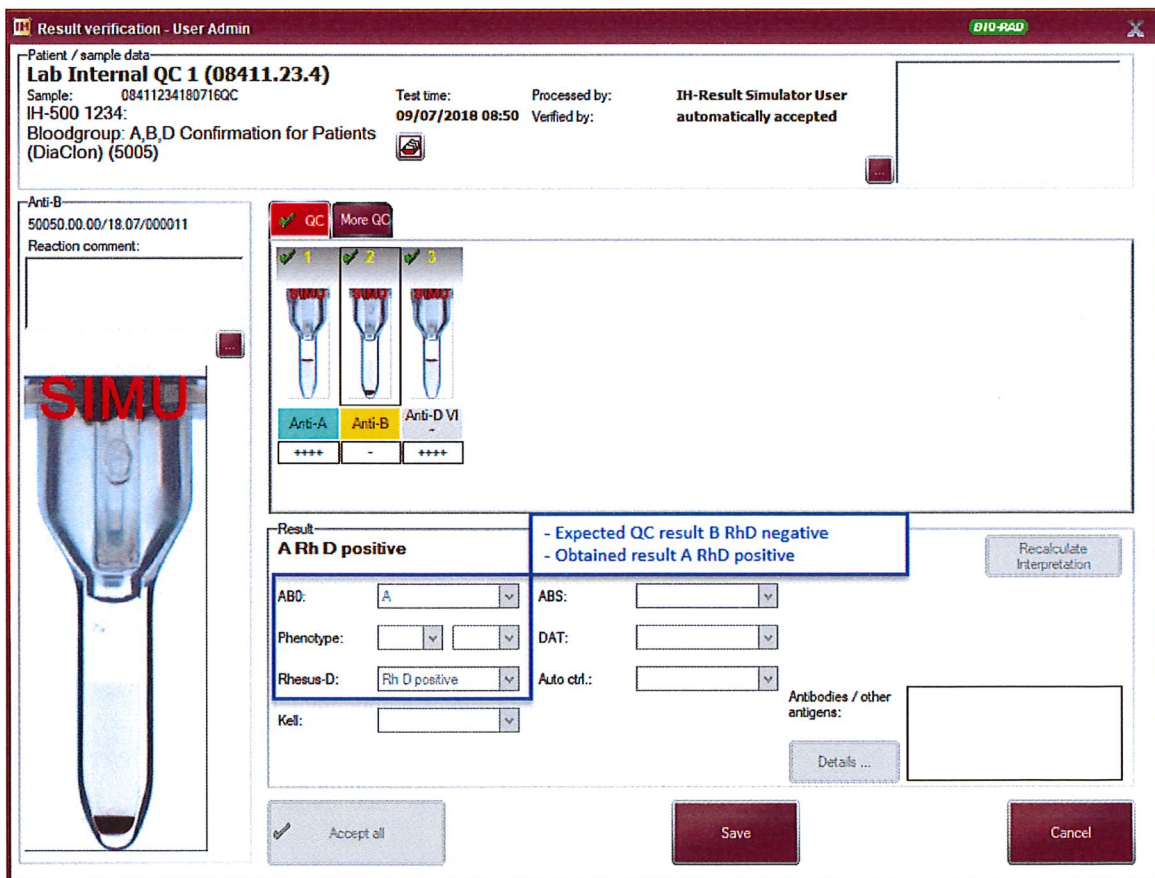
Figure 1: ABO forward example in IH-Com result verification.

A problem occurs during the test of this QC sample, the obtained result is A Rh positive whereas the expected result is B Rh negative and this QC was accepted by IH-Com ("QC pass" shown below (1))

This anomaly will be definitively corrected by installing a service pack which will be released beginning of Q4 2018.
