Name M.A. Roland Ertl
 Department SHS EMEA CEET QT
 Telephone +43 51707-38274
 Mobile +43 (664) 8011738274
 E-mail roland.re.ertl@siemens-healthineers.com
 Date January 14, 2020
 Document Ref# ASW20-02.A.OUS

Urgent Field Safety Notice:

Atellica® IM 1300 Analyzer / Atellica® IM 1600 Analyzer

Humidity Packs Incorrectly Identified as Expired (Lot 0010)

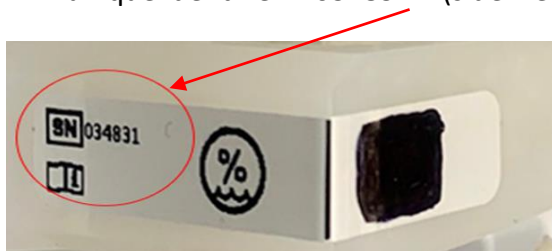
- c. The unique identifier on the Humidity Pack label is depicted below. In this example the unique identifier is 034831. (side view)

1. Cover the existing Humidity Pack 2D barcode with permanent marker so it cannot be read by the system. Do not remove the original barcode. (top view)
