FSCA Ref: 656504 & 661861

Date: 12.08.2022

Urgent Field Safety Notice HLS Set 7050 & HLS Set 5050

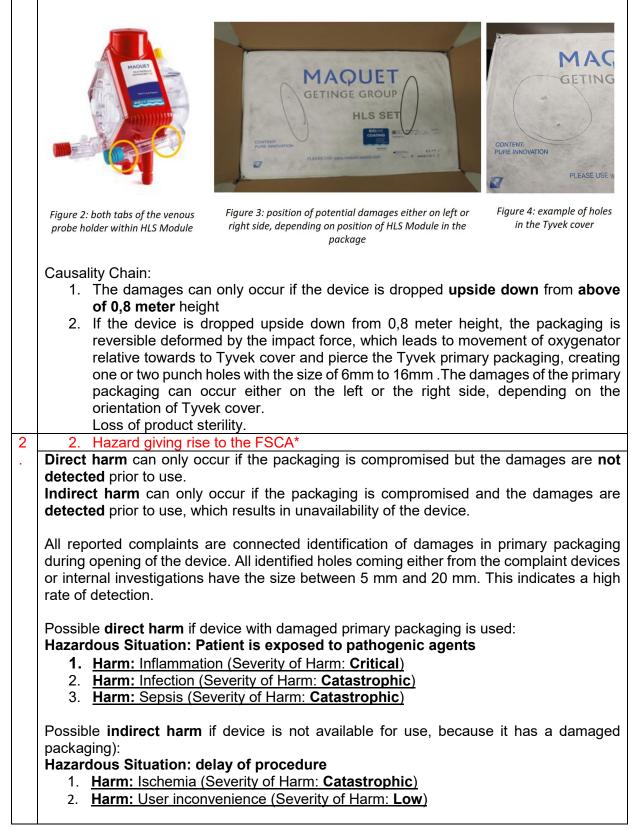
2 Reason for Field Safety Corrective Action (FSCA)*		
1	2	 Description of the product problem* 	
		The HLS Set Advanced is intended for use in an extracorporeal circulation for cardiac support and/ or pulmonary support. Maquet Cardiopulmonary GmbH (MCP) has received customer complaints of damage to the primary packaging of the HLS Set Advanced.	
		In all customer complaints it was reported that the Tyvek cover was damaged. The appearance of the packaging failure can be hole(s) in the Tyvek.

The damages are caused by the tabs of the venous probe holder within the packaging (figure 2). Consequently, depending on the orientation of the Tyvek cover on HLS tray, holes can appear either on the left or right side of the Tyvek (figure 3 and 4), which corresponds to the position of the venous probe holder.

3. If a product is already in use, it should remain in use.
	Option 2 (on-site device inspection) : If the products are necessary based on expert clinical judgement, you can use the devices after following these inspection measures:
	 Prior to use, the HLS Sets Tray covers have to be checked visually for any damages, holes or tears in order to prevent the use of an unsterile medical device. After removing the tray from the secondary package (white cardboard box), position the tray in a well-lit area outside the sterile field.

3. Check the integrity of the sterile barrier of the tray (Tyvek cover) before use. If any doubt arises as to package integrity, then it should not be used. Any product with damaged packaging must be returned to the local Getinge representative.
	 Please note, that all products which you can receive at this time contains old packaging design and they have affixed "Inspection instruction" on the white box.
	Regardless of the decision you make, please complete and sign the attached customer response form and send it back to your local Getinge representative.
	Please report any adverse events in regards to the affected products to your Getinge Representative.
	Transmission of the Field Safety Notice:
