Urgent Field Safety Notice

SBN-CPS-2019-015

CPS / Serum Work Area Systems

Potential malfunction in high pressure solenoid valves

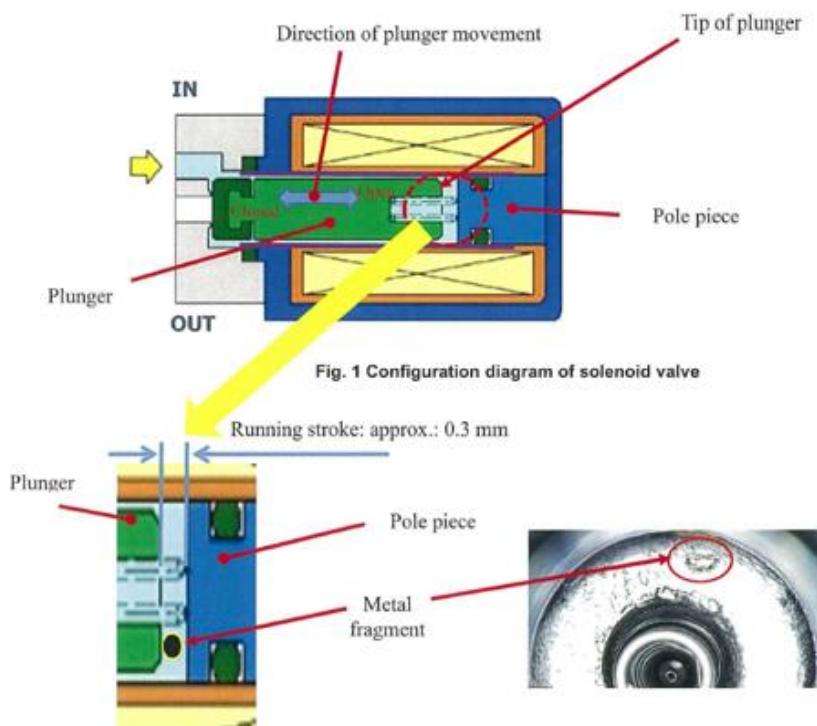
The root cause is related to metallic fragments peeling from the plunger in the solenoid valve. This metal fragment may prevent proper plunger movement and accordingly lead to potential malfunctioning of the solenoid valve opening/closing functionality (solenoid valve totally open and solenoid totally closed mode).

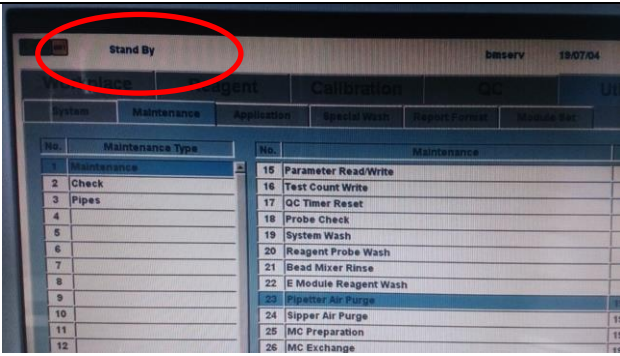
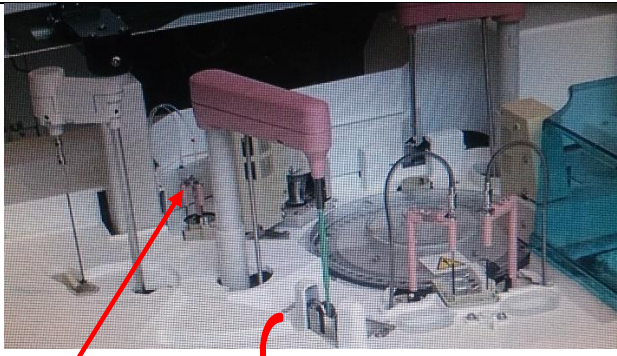
Appendix 1: stand-by mode, open cover and how to locate both wash stations for reagent probe and for pre-wash sipper probe:

<p>Pre-wash sipper probe wash station</p> <p>Reagent probe wash station</p>
Stand-by mode	Wash stations as seen with open cover

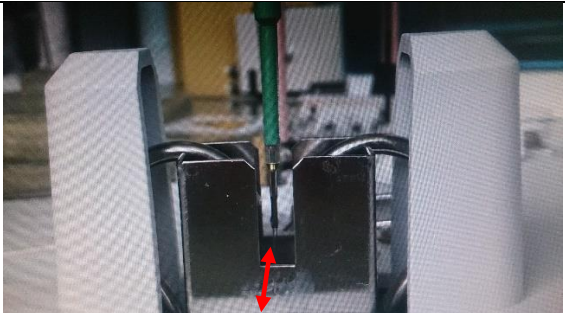
<p>jet of liquid leaving probe</p>
--	---

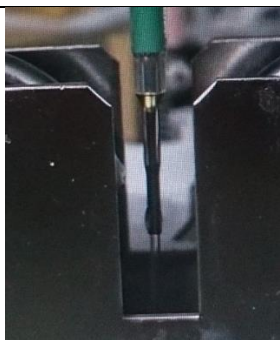
<p>constant jet of liquid for approx. 1 sec</p>

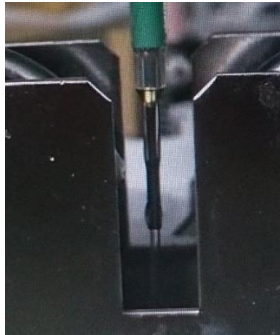
<p>constant jet of liquid for approx. 1 sec</p>

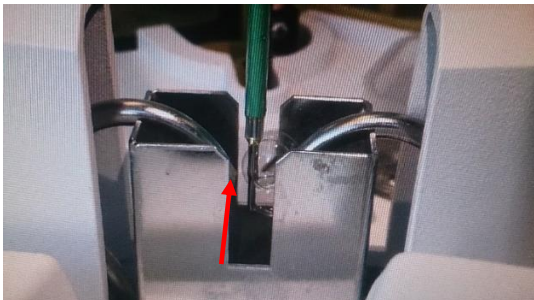
<p>Foam at end of reagent probe</p>
--	--

<p>Ok: a regular repeated jet of liquid is ejected from reagent needle into wash station for approx. 1 sec, then a pause with no liquid for approx. 1sec, then cycle starts from the beginning</p>	<p>Not ok:</p> <ul style="list-style-type: none"> - no jet of liquid, - air bubbles, foam - constant, not interrupted flow coming out of reagent probe
--	---
