To our customers of the Dräger Oxylog VE300 ventilator with optional carrying system holder

February 2020

Important Safety Notice!!!

**Possibility of the Oxylog VE300 falling out of the carrying system holder.
Only devices specified in the attached serial number list are affected.**

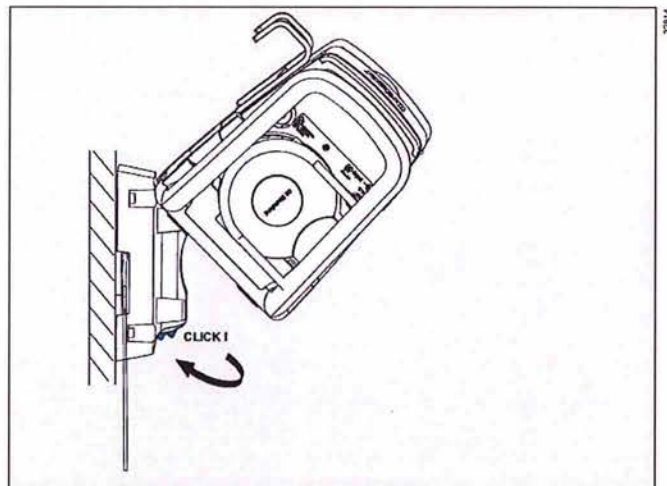
- 1 Insert the device in the middle of the upper socket.
- 2 Press the device into the lower latch until it audibly clicks into place.
- 3 Make sure that the device is properly secured.

The Oxylog VE300 ventilators with carrying system can continue to be used safely. To do so, it is necessary to attach the device to the carrying system holder as described in the Instructions for Use of the carrying system holder, and to ensure in particular

1. that the device is inserted in the middle of the socket (parallel to the wall-mounted plate) and
2. that the device is correctly latched into the carrying system holder and
3. as a final step to check that the device is properly secured by pulling the handle.

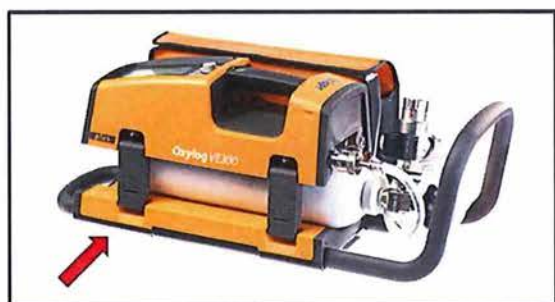
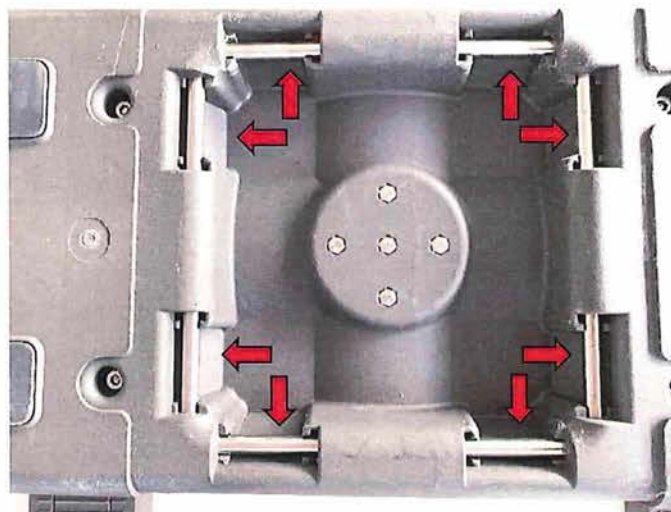
Within the framework of our continuous market surveillance activities, a case has come to our attention in which the Oxylog VE300 ventilator became detached from the wall-mounted carrying system holder. This was because an axis was missing from the attachment mechanism on the bottom of the device. The missing axis meant that the device was not firmly latched into the carrying system holder. No patient or user was injured in the reported case. However, due to the weight of the device, it is not possible to rule out the risk of injury if the incident were to recur.

Furthermore, we would like to ask you to carry out an additional check. Before using the device, please verify that all 8 axes are present and in the correct places, as shown in the pictures below.

Please do not continue to place the device in the carrying system holder if you detect any inconsistencies in the attachment mechanism.

Your local DrägerService will contact you to organize replacement of axes in the attachment mechanism by a new and improved version of axes.
