To our customers of  
Atlan A300, Atlan A300XL  
Atlan A350, Atlan A350XL

August 2021

## Important Safety Notice

### Artefacts on pressure and flow curve

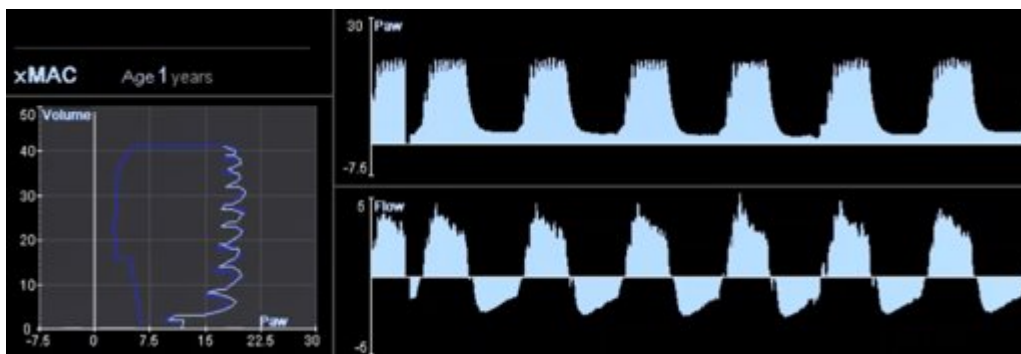
Artefacts on pressure and flow curve

During the course of our global market surveillance activities, we have become aware of very rare cases in which the Atlan Anesthesia Workstation with SW 1.01 has shown artefacts on the pressure and flow curves while the devices are being operated in one of the following ventilation modes: PC - CMV, PC - SIMV, PC - SIMV / PS, VC - CMV / Autoflow, VC - SIMV / Autoflow, VC - SIMV / PS / Autoflow, CPAP / PSV.

Our investigation revealed that these artefacts occur only in rare combinations of certain resistance and compliance combinations of the whole system of e.g. filters, breathing hoses, ET-tube, patient lung and leakages. Although these artefacts are visible on the displayed pressure and flow curve and may be audible during auscultation, the pressure or flow spikes will not reach the patients lungs, due to the low pass filter effect of the resistance in the endotracheal tube and the upper airways.

**However, we cannot exclude that the pressure and flow pattern shown on the display might cause confusion to the clinical user, potentially resulting in an improper therapy decision. As of today, no injury has been reported to Dräger in this context.**

Dräger is currently working on a software update, which will remedy the issue. Your local Dräger representative will contact you as soon as the new software is available, in order to schedule the device update. The software update will be provided free of charge

Until the software update is available you may continue using the device and affected ventilation modes, making sure that therapy decisions are not made based only on these artefacts.

Switching to one of the unaffected ventilation modes, will prevent occurrence of these artefacts.
