Field Safety Notice

2019-APR-17 | REF-MSA-2019-001-IU|

Subject: Cracked coating fork on VOLISTA light

Products affected: All Getinge VOLISTA light head of model STANDOP and TRIOP manufactured until July 2017

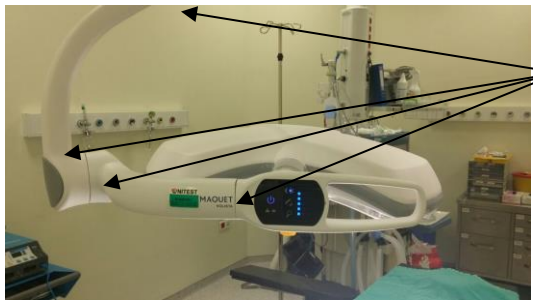
Under certain conditions, we have identified an issue that might prevent the device from performing as intended. Maquet SAS, the manufacturer, received some complaints regarding light head fork (yokes). It was established that the coating of those forks might show cracks. Therefore, there is a risk that particles may fall and generate infection. Maquet SAS didn't received any adverse event (i.e. infection) regarding this issue.

- The coating cracks can be observed on both side of each fork, as you can see on the pictures below:

4 possibles locations of cracks

- Before using the device, please inspect the fork and check if cracks on the coating are visible, as shown in the picture here below

If you detect a coating crack on the fork, please STOP USING the device and contact your Getinge representative.

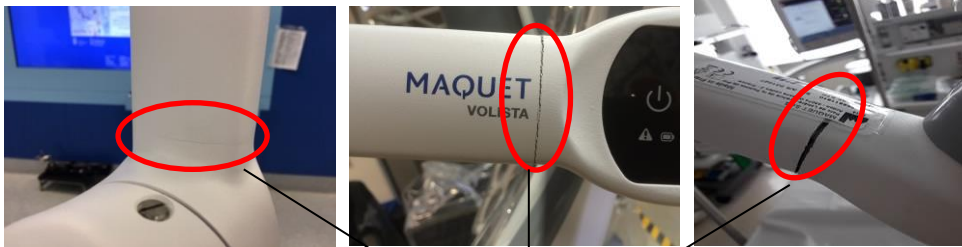
- The coating cracks can be different size, as explained below:

Pictures of the coating crack with different size
