2019-NOV-20 | REF-MSA-2019-001-IU|

### Subject: Cracked coating fork on VOLISTA light

Products affected: All Getinge VOLISTA light head of model STANDOP and TRIOP manufactured until July 2017

Field Safety Notice no. 2 | 2019-NOV-20 | MSA-2019-001-IU |

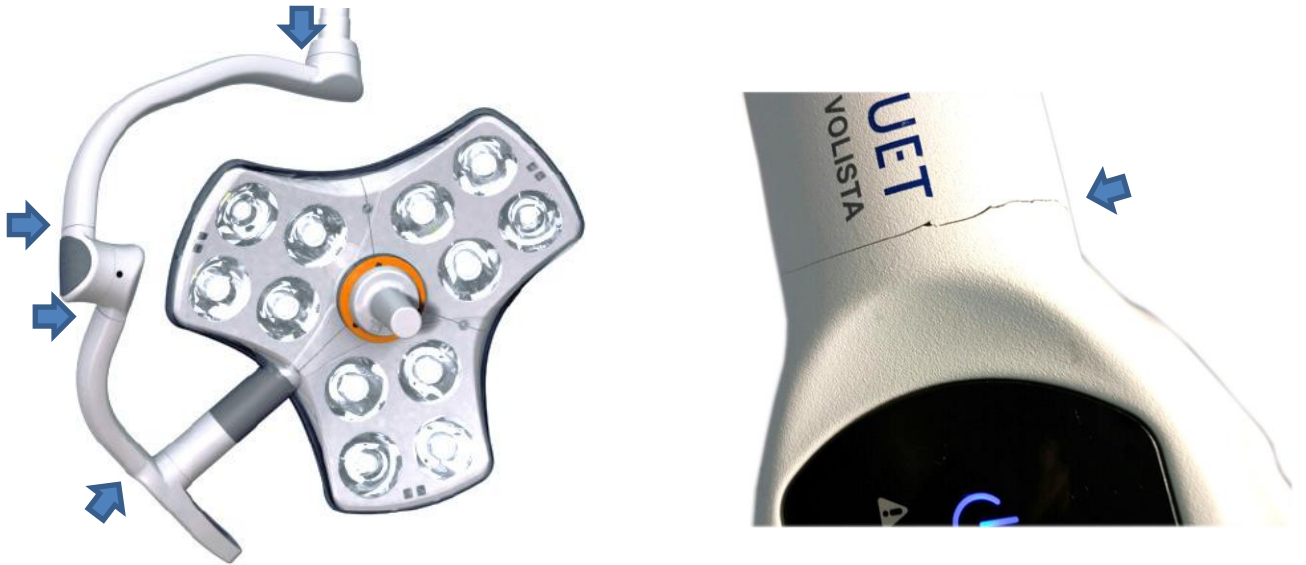
**Fig. 1: Coating crack phenomenon**

In April/May 2019 Maquet SAS has launched a field action concerning possible coating cracks that may appear on Volista Standop or Triop fork manufactured prior July 2017 (See fig. 1). This issue may result in a potential injury if particles fall during surgical operation in the surgical field, generating then possible infection to patient

This is a temporary solution to allow you to safely continue to use your lights. However Maquet SAS is committed to replace each defective fork to ensure a fully remediated device for the rest of its shelf life.

- Contact your local Getinge representative,
- Getinge representative will then place the adhesive solution or provide you with (see fig.2),
- And as soon as practical, the Getinge representative will proceed with the replacement of the fork with a new generation of forks.

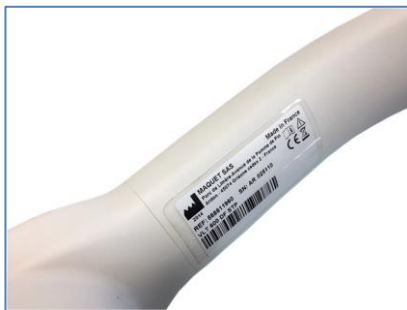
**Fig. 2: Validated adhesive technical solution**

Localise the coating crack.

The solution consists on a validated adhesive strip that is resistant to mechanical stresses and to representative chemical agents used in the operating rooms. This solution has been used in some accounts with satisfactory results.
