**URGENT FIELD SAFETY NOTICE
UPDATED**

Philips EPIQ & Affiniti Ultrasound Systems
System Lock-Up Issue and PW Doppler
Signal Dual Mode Issue

04 - OCT - 2021

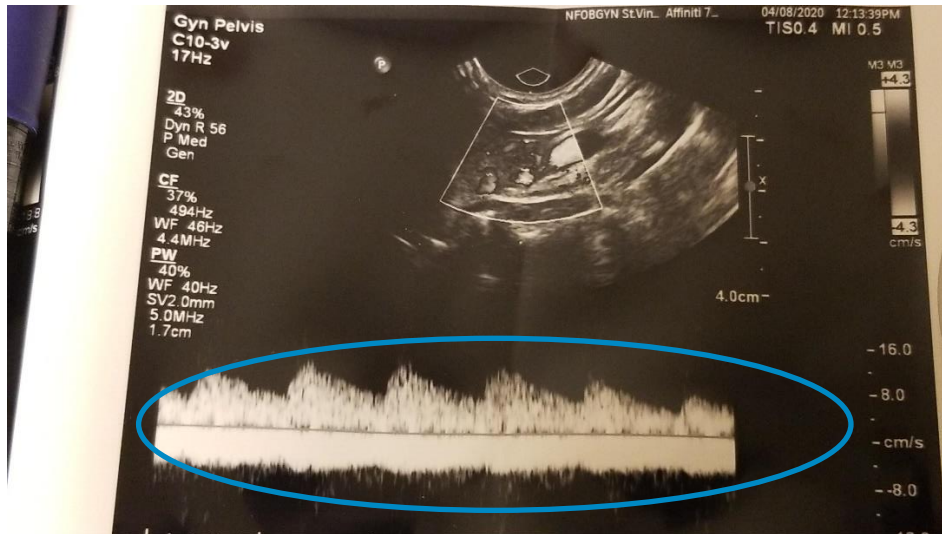
Figure 1 shows a normal PW Doppler signal, highlighted in the blue oval. When the issue occurs, this signal is compromised as shown in Figure 2 below, highlighted by the red oval.

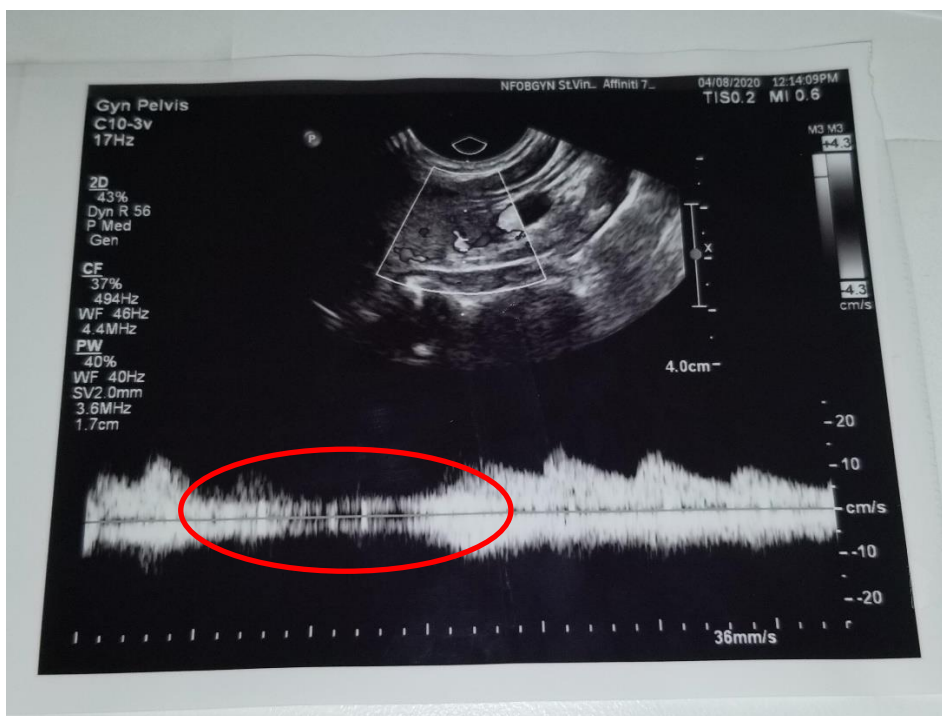
Figure 2

Philips Ultrasound has identified an issue where the Pulse Wave (PW) Doppler signal, both visual and

audio can be compromised under specific workflows.

The issue occurs if a user enters Dual Mode, exits Dual Mode and then turns on the PW Doppler signal. The PW Doppler signal cannot be engaged while in Dual Mode, so the user must leave this Mode to use PW Doppler. At this point, having been in Dual Mode creates the issue in the PW Doppler Signal.

The PW Doppler function can be used prior to entering Dual Mode. This avoids the issue by **preventing** the Dual Mode from impacting the use of the PW Doppler function.

- 1) The user can reselect the transducer after exiting Dual Mode which will resolve the issue in the signal allowing normal use of the PW Doppler function. Note, this mitigation would need to be used each time the user goes into and exits Dual Mode. Note, any function which reselects the transducer, such as closing and opening the exam will also solve the problem.
- 2) The user can validate their PW Doppler signal using a different Doppler Mode such as Color Doppler. Color Doppler is not affected by this issue. Note, Color Doppler is a different clinical function. However, its output correlates to the PW Doppler output to indicate to the user there is a problem.
