**MEDICAL DEVICE CORRECTION NOTIFICATION
FIELD SAFETY NOTICE**

09 August 2018

Subject IGC PCB (for TrueBeam installations only) does not provide an RTInterface error in the event of an I/O error between the IGC PCB and the Framegrabber PCB

Commercial name of product: AlignRT

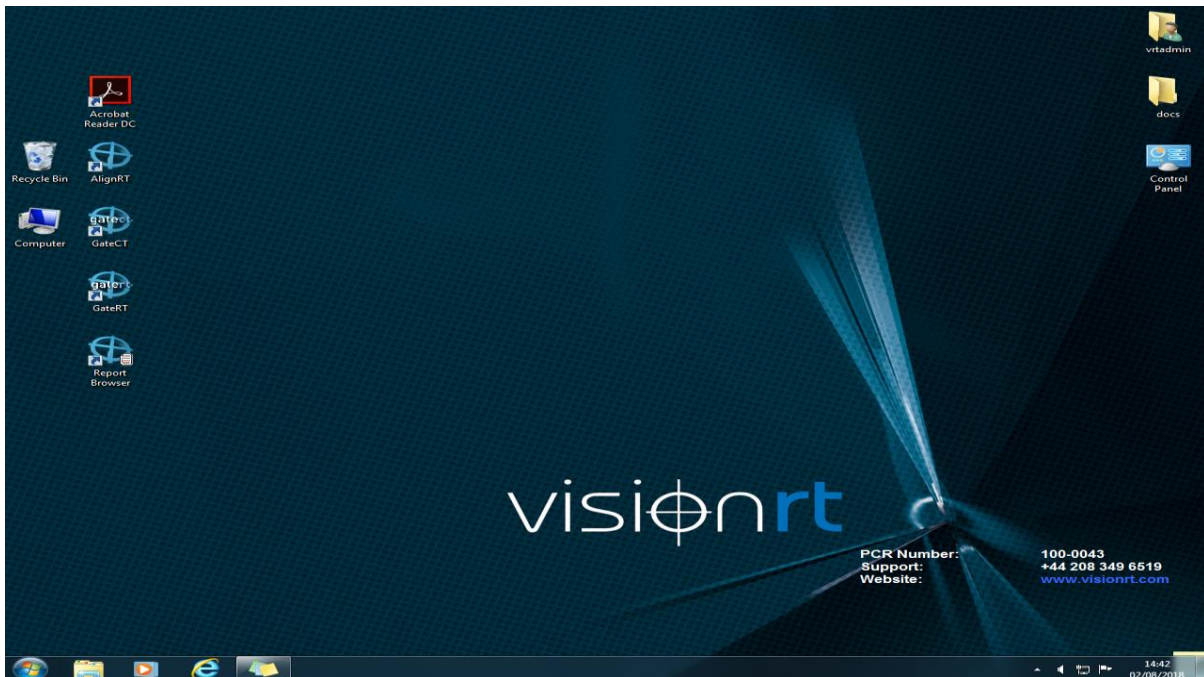
Figure 2 - Typical Desktop Showing AlignRT Has Been Closed

IMPORTANT – ensure that the application has been closed and not simply minimised. Check this by ensuring that the application is NOT shown in the task bar at the bottom of the desktop.

Please ensure that your workstation is left in this state between 12pm and 5am (your local time) in the nights of the 21st August through to 31st August. If you do not do this, or do not have a network connection to your workstation, this will be identified by our service team who will make contact with you to arrange the update of your system directly. In some cases, you may be contacted by our local distributor instead.
