FIELD CORRECTIVE ACTION NOTICE

Leica M525 F20 Microscope System

FCA Identifier: CAPA-HER-MD-18-001

Enhancement of instructions for use and additional markings to prevent inadvertent tipping

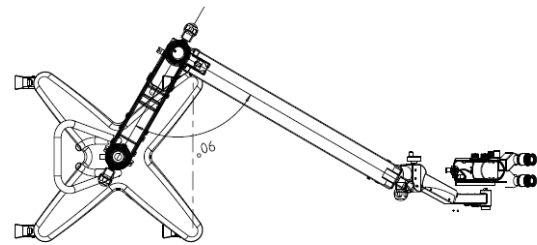
Figure 2: Top view of Leica M525 F20 Microscope

Intended correct positioning:

~ 90° between horizontal arm and swing arm

- You can continue to use the system pending availability of the enhanced user manual and the additional markings as described in Attachment 1:
 - Ensure that your Leica M525 F20 is positioned and handled with an angle of approximately 90° between horizontal arm and swing arm during surgery as well as during set-up and preparation (see Figure 2 and Attachment 1).

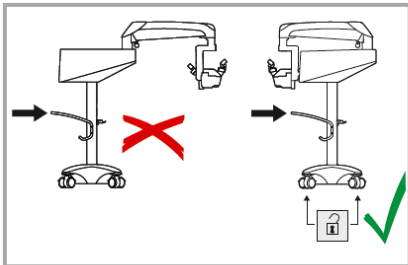
<p>Never move stand in the extended position.</p>

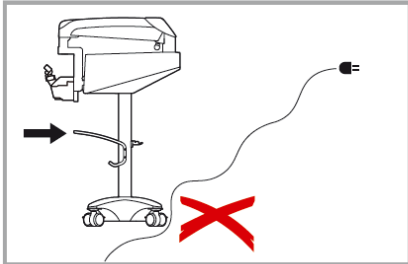
<p>Never roll over cables lying on the floor.</p>

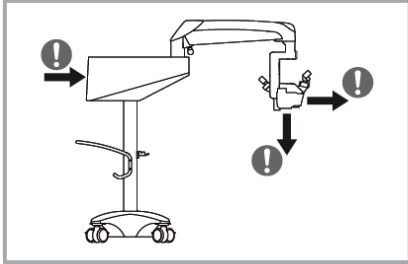
<p>Do not allow vertical and horizontal forces to the stand in the extended position.</p>

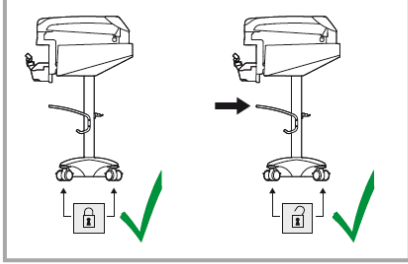
<p>Always lock the foot brake when you are not moving the system. Always open the foot brake when you are moving the system.</p>

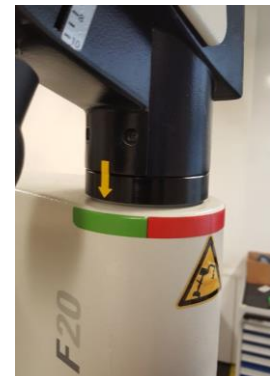
Figure C: Scale Indicator

- The yellow arrow pointing to the green area shows that the device is set up as intended.
- The yellow arrow pointing to the red area shows that the device is not set up as intended and special care is needed to prevent inadvertent tipping when handling the device.

An additional marking with a scale indicator and arrow as shown above in Figure C will assist Leica M525 F20 users to position the horizontal arm and swing arm with as intended with an angle of approximately 90°:
