IMPORTANT MEDICAL DEVICE ADVISORY

HeartMate 3™ Left Ventricular Assist System Catalog # 106524INT – LVAS KIT, HM 3 105581INT – Packaged assembly Outflow, HM3(INT)

DATE, 2017

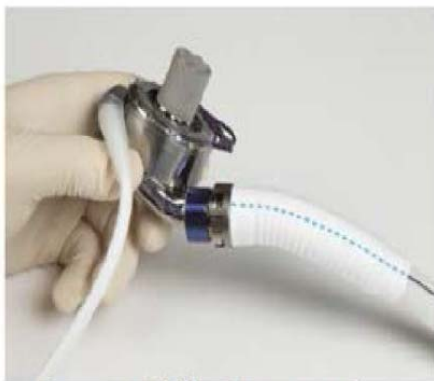
Figure 2

Correct: Fully Connected

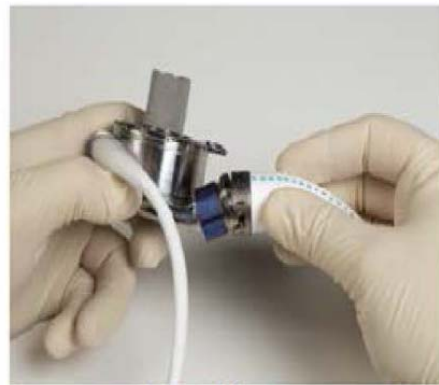
Abbott has observed cases in which the outflow graft bend relief (OGBR) on the HeartMate 3 (HM3) Left Ventricular Assist System (LVAS) was not fully and evenly secured to the outflow graft. As a result, we conducted an internal review of x-rays from both the U.S. MOMENTUM 3 IDE and Continuous Access Protocol (CAP) studies, and identified additional cases where the OGBR was not properly secured.

There may be no symptoms associated with an OGBR that is not fully and evenly connected; however, there is potential: (1) for kinking of the outflow graft leading to a low flow state that may result in heart failure symptoms and reoperation; or (2) for mechanical wear and tear of the outflow graft leading to intra-pericardial bleeding potentially causing hemodynamic compromise that may require emergency surgery.

Incorrect: Not Fully Connected

- For patients already implanted with the HM3 LVAS, please review a current x-ray to ensure the OGBR is fully and evenly secured to the outflow graft. Where images of the outflow graft and bend relief are not available, please take images at the patient's next visit and review to ensure the OGBR is properly secured.

- For newly implanted patients, please take an x-ray one day post-implant and review it to ensure the OGBR is fully and evenly secured.

- If a disconnected OGBR is identified during x-ray review, physicians should determine patient care recommendations based on each unique clinical case. Additionally, review with your Abbott clinical specialist to file a complaint through the normal complaint process.
