Ref: MRBR-23H004

Field Safety Notice

RADspeed Pro
RADspeed safire
CEILING TUBE SUPPORT CH-200
CEILING TUBE SUPPORT CH-200M

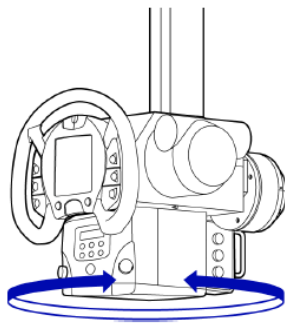
Fig. 1 Rotation around Vertical Axis

We have identified potential problems with some of the above Shimadzu products. The CEILING TUBE SUPPORT for the above device consists of an X-ray Tube Support Pull-up Section and an X-ray Tube Support Section to which an X-ray tube assembly is mounted, and the tube holding section is secured to the column of the X-ray tube X-ray Tube Support Pull-up Section with eight bolts. It turned out that this bolt could come loose. In use, we think that loosening of the fixed bolt will not occur unless the bolt is repeatedly subjected to strong impact on the mechanical stopper or the like during the vertical axis rotation operation, but if loosening of the bolt increases, the bolt may break. If all eight bolts break, the X-ray Tube Support Section may eventually come off the column.

- Perform daily inspections according to the CH -200/CH -200 M operation manual. In particular, check if there is any abnormality such as the X-ray tube device being able to rotate around vertical axis (see Fig .1 below) without pressing any button on the control panel. if any abnormal points are observed, stop using the equipment and contact Shimadzu service representative.
- When rotating the X-ray tube assembly, do not hit the X-ray tube assembly against the stopper at the end.
If the X-ray tube assembly is hit hard against the stopper, the bolt may be impacted, causing it to loosen and break.
- Do not rotate the X-ray tube assembly above or near the patient.

In the unlikely event that all the bolts break, we will add protective parts so that the X-ray Tube Support Section does not come off the column. At the same time, we will replace the bolts that secured the X-ray Tube Support Section.
