URGENT – FIELD SAFETY NOTICE

Nimbus 4 & Nimbus Professional mattress – risk of over-inflation

Affected Product: Arjo Nimbus 4 & Nimbus Professional mattress

Field Safety Notice: FSN-SUZ-001-2021

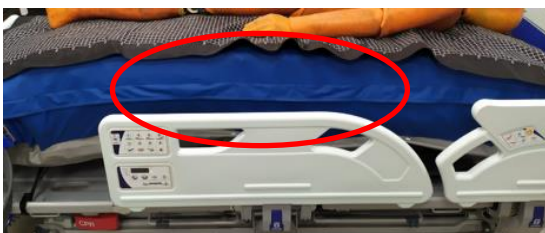
Arjo has received limited reports of the Nimbus 4/Professional mattress over-inflating which requires an unusual set of circumstances to occur. This is a very rare occurrence and there have been no reports of health consequences to either patients or caregivers due to this issue.

Our investigation has concluded that there is a remote possibility that a patient could fall from the mattress if the issue was to occur and was not detected by care givers. The issue is caused by inner mattress components that may fail after a certain period of time, however this is extremely rare and unfortunately cannot be detected until the product is disassembled.

} Malfunctioning mattress

1. Transfer the patient to another appropriate surface
2. Turn off and unplug the pump.
3. Perform grommet membrane deactivation as instructed in the video to allow the accumulated air to freely vent out. Use a screw driver with a diameter of 2 – 3 mm. Make sure that the membrane is punctured through.

NOTE: The grommet membrane restricts the volume of excess air escaping. Removing the membrane will not affect mattress functionality in any way other than to allow excess air to escape at a slightly higher rate. This process does not introduce any new risks.
