Field Safety Notice

Affected Products: Shimadzu CVS system : Trinias

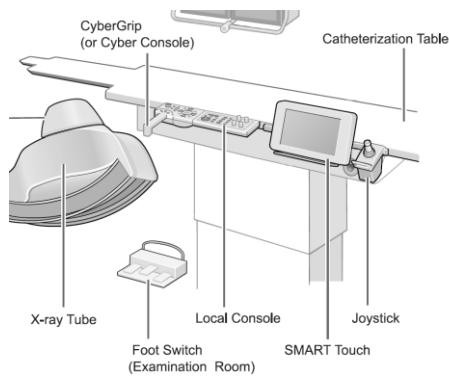
Figure 1

If SMART Touch is installed as shown in Figure 1, press the "X-Ray OFF" button shown in Figure 2 to stop X-ray output.
