Field Notice

HysteroLux™ Fluid Management System Control Unit – REF 72205000

WOM reference no.: 2021-0002

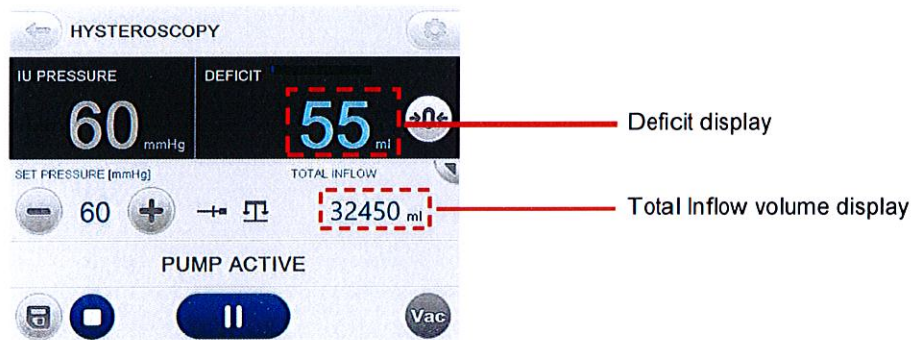
This field notification is being issued following reports from customers from the USA that the display of inflow volume on the HysteroLux™ Fluid Management System can reach its limit of 32,450 ml during long procedures. In these cases, the display does not indicate the actual inflow volume. In cases where an unusually high amount of fluid is used for distension of the patient's uterus, the calculation of the inflow and outflow volumes reaches its limit and the Control Unit display will freeze at the maximum value.

Our investigation has identified a software anomaly as the cause for this display freeze. The reason for this is that at 32,450 ml an internal software calculation threshold is being reached. As the outflow measurement will continue, the result is that the deficit accumulated up to this point will start counting backwards until 0 ml is reached.

Figure 1 Pump Control Unit display showing the calculated deficit (Deficit display) and inflow volume count (Total Inflow volume display). The latter will freeze, once 32,450 ml has been reached.

W.O.M. WORLF OF MEDICINE GmbH has developed a software version, which, when an inflow volume of 28.000 ml is reached, alerts the user that the limit is being approached and is designed to prepare the user for a manual determination of the deficit.

The new software version is implemented during the next preventive maintenance of your HysteroLux™ Fluid Management System Control Unit. If you wish to update the software of your device at an earlier date, please contact your sales representative of Medtronic Inc., who will assist in returning the unit and providing an exchange unit.
