25. August 2023

FIELD SAFETY NOTICE
for End-Customers using
Hamilton Medical In2Flow Nasal cannulas
Reference #: FSCA 2023-08-04

Recipients: Health care facilities using In2Flow Nasal cannulas from Hamilton Medical AG.

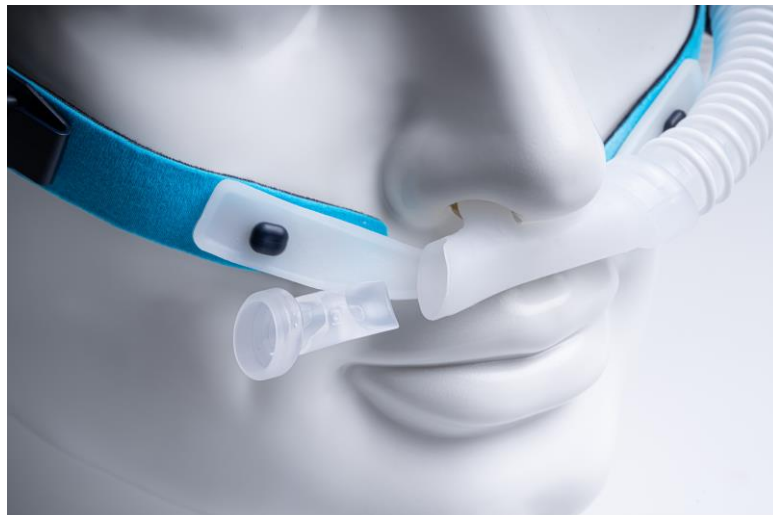
Failure description: Several complaints were received where the plug (the one at the opposite side of the tubing) became detached from the In2Flow Nasal cannula, causing leakage due to unintentional disconnection of that part. This may result in degraded high flow support and oxygen delivery, which may lead to patient O₂ desaturation.

Figure 1: An In2Flow Nasal cannula size M is shown. The plug became detached from the opposite side of the tubing. (This is an example; sizes S and L are also affected.)

Failure effect: In case the plug becomes detached from the In2Flow Nasal cannula during high flow therapy desaturation of the patient with SpO₂ < 80% might result.

2. Check if plug of In2Flow Nasal cannula became detached.
 3. If the plug is still in place, check for other reasons for O2 desaturation.
 4. If the plug became detached, exchange the affected In2Flow Nasal cannula, and use a new In2Flow Nasal cannula.
