**FSN Ref:** 2025-FSN-0000124

**FSCA Ref:** 2025-FA-0000124

**Date:** 2026-01-28

**URGENT Field Safety Notice**  
**Risk of Differential Pressure (dP) Sensor drift in Impella RP Devices**

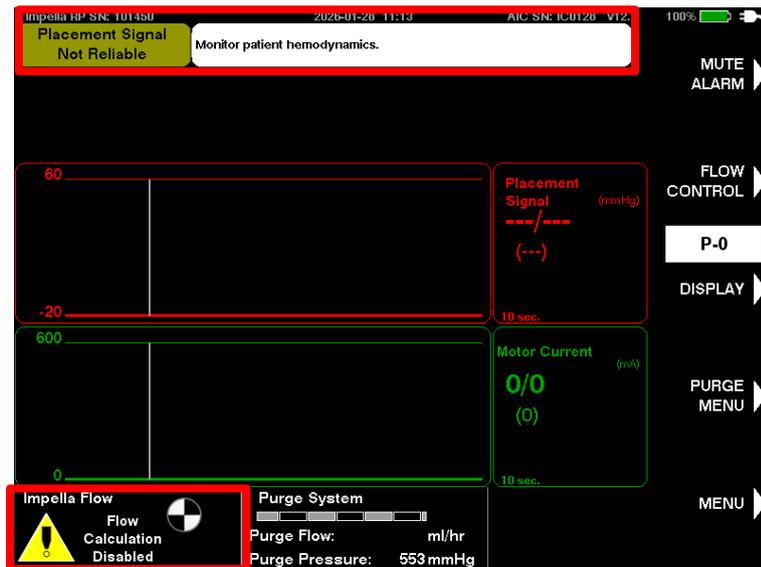
2.	1. Description of the product problem* Abiomed has identified a risk of Differential Pressure (dP) sensor drift in Impella RP pumps, which may cause inaccurate flow readings and Placement Signal. The dP sensor measures the pressure difference between the inlet and outlet of the RP Impella pump which serves as an input for the pump metrics listed above. There is no way to confirm error in the flow calculation directly from the pump signals in these situations. When the dP sensor signal exceeds the operating range for the sensor, the flow calculation will disable and a "Placement Signal Not Reliable" (PSNR) alarm will be displayed on the AIC, as shown in Figure 1. Please note that the PSNR alarm may not be triggered in all instances of dP sensor drift.  <b>The dP sensor does not affect the pump's ability to provide hemodynamic support.</b> Pump flow is driven by the motor current and does not rely on the pressure sensor.

Figure 1: Example AIC screen during PSNR due to the dP sensor

- continue to monitor patient hemodynamics with approved diagnostic devices and continue to verify Impella positioning with imaging before clinical interventions.
- refer to the P-level flow rates listed in the Instructions for Use (IFUs), as shown in Figure 2, and rely on these values rather than the AIC display. The values in the IFU reflect the flow rate range of the pump on defined pressure gradients under controlled conditions. Clinicians should be aware that actual pump flow depends on preload, afterload, and can vary due to suction, incorrect positioning, or presence of thrombus in the inlet.
