## **IMPORTANT FIELD SAFETY NOTICE**

CentriMag™ Acute Circulatory Support System Motor Model: 201-10002  
*Compatible with CentriMag™ Pump and PediVas™ Pump*

September 5, 2018

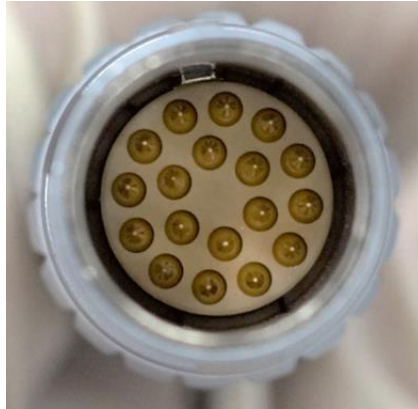
**Figure 2: Motor Connector Pin View**

- Visual inspection regarding inspection for motor cable damage from the CentriMag Circulatory Support System Operating Manual and supplemental pages (for 1<sup>st</sup> Generation Consoles)
1. Visually inspect the CentriMag Motor connector for bent or broken pins. Check for burn marks or melted plastic.

Note: If there are any issues while connecting the CentriMag Motor to the CentriMag Console, inspect the Motor port on the rear of the Console for damage, particularly for any broken pins that may be lodged inside.

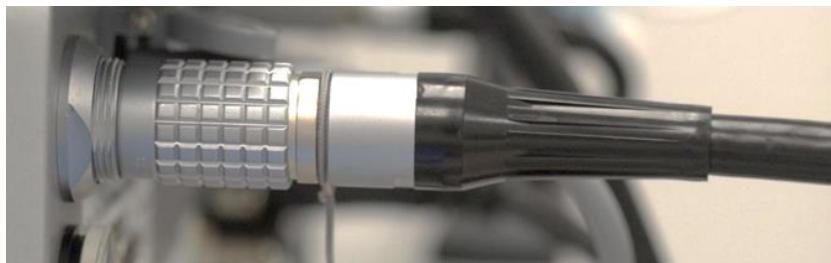
**Figure 3: Cable Bend Relief at the Console Connector**

2. Visually inspect the entire length of the CentriMag Motor cable, including both bend reliefs (see Figures 3 and 4), for any damage such as separations of the bend reliefs, deformations, kinks, or cuts. These types of damage indicate wear and tear or previous rough handling of the cable, which has the potential to result in internal wire damage. Cable thickness and shape should be uniform throughout the length of the cable.

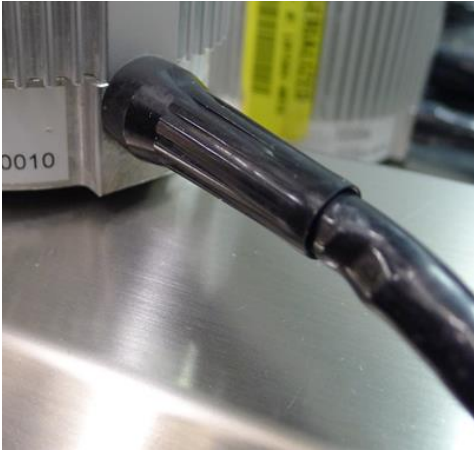
Our analysis of devices associated with the motor stop field complaints showed that the motor stop can be attributed to a break of a wire or short circuit between wires within the electrical cable where the cable exits the motor cable bend protection. This damage may be avoided by ensuring proper handling, such as avoiding tight bending of the cable, or winding the cable around the motor during storage during the life of the motor.

**Figure 5: Cable Damage at the Motor Bend Relief**

Before each use, verify that the cable connecting the Motor to the Console is not kinked, which can occur with improper handling such as wrapping the cable tightly around the Motor. If the cable is kinked, replace the Motor.

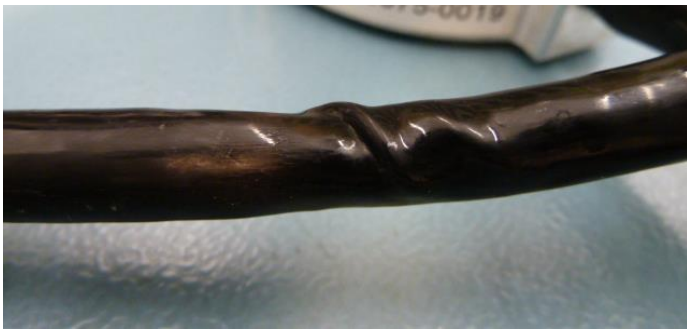
**Figure 7: Damaged Motor Cable**

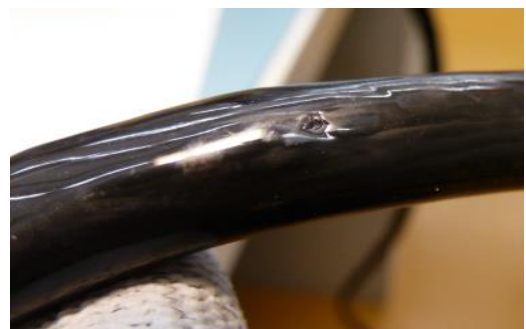
**Figure 8: Damaged Motor Cable**
