**UPDATE**  
**URGENT FIELD SAFETY NOTICE**  
**MEDICAL DEVICE CORRECTION**

**MAQUET CARDIOSAVE hybrid and MAQUET CARDIOSAVE rescue**

<b>Product Code/Part Number:</b>	<b>0998-XX-0800-XX</b>
<b>Distributed Affected Lot Number:</b>	<b>All</b>
<b>Distribution Dates:</b>	<b>Since March 6, 2012</b>

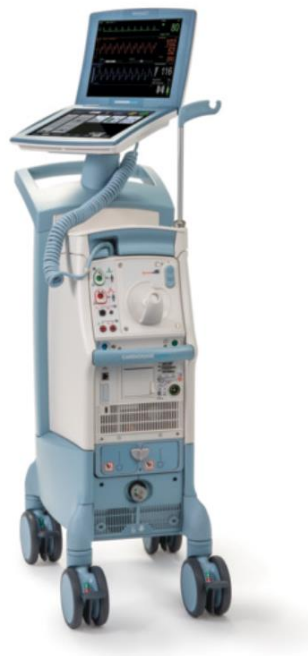
**Figure 3: Cardiosave in Hybrid Configuration**

Unexpected shutdown can only happen while in Hybrid Configuration (Figure 3) when all four of the below conditions are met:

1. IABP is running on AC power and charging a single battery in voltage charging mode. Voltage charging mode occurs during the last 15-20 minutes of the full charging cycle, when the 5<sup>th</sup> and final LED charge indicator on the battery pack is flashing.
2. The other battery bay is empty, i.e. no battery is inserted into the second battery bay.
3. The battery is ejected while a system signal erroneously reports the AC power supply is low, this will only happen intermittently when the first two conditions are met.
4. Battery is ejected when all above conditions are met.

To ensure that the Cardiosave Hybrid is not susceptible to the shutdown during the removal of a battery, users should not eject a battery when:

- There is a singular battery in either battery charging bay and unused battery bay is empty.
- The battery is charging on AC power (indicated by a flashing LED on the battery pack).

Additionally, the user can prevent the issue by ensuring that a battery is inserted into each of the two battery bays. Should a charging battery be ejected inadvertently, the unit will automatically switch over to the second battery, thus preventing system shutdown.

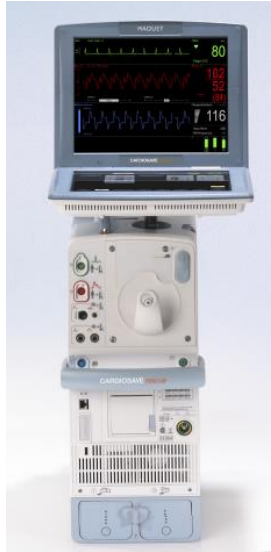
**Figure 4: Cardiosave in Transport Configuration**

An unexpected shutdown upon battery removal cannot occur for Cardiosave Rescue.
