To our customers of the
Emergency and Transport Ventilator
Oxylog 3000 *plus*

Important Safety Notice

Oxylog 3000 *plus* may not switch to mains supply following battery operation.

All Oxylog 3000 *plus* devices Part No 5704811 and 5704813,
Basic UDI DI 040486751304015FK19Z000XW, may be affected.

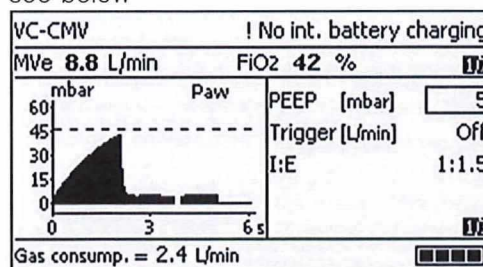
The root cause of the inability to switch to mains supply could be identified as a problem of the charging circuit which can occur in the following sequence of situations:

1. a prior battery issue indicated by the alarm "No int. battery charging" occurred during use on mains supply – see below

Please make sure that the battery is always removed and reinserted or replaced after occurrence of the **"No int. battery charging"** alarm message, without removing the device from mains supply.

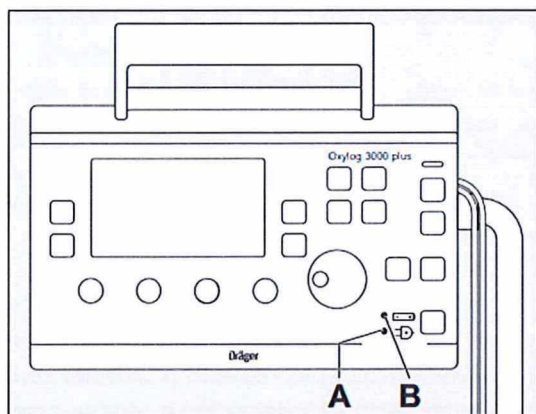
Prior to a device being used on a battery supply, ensure the correct switchover by disconnecting from and reconnecting the device to a mains supply. Please verify the colors of indicators A and B as per the diagram below:

A should display a green light, and B should display a green or yellow light. If B displays a red light, you should disconnect and reconnect or replace the battery.
