# **URGENT Field Safety Notice**

## ABL90 FLEX and ABL90 FLEX PLUS

# - Risk of incorrect time and potentially biased results

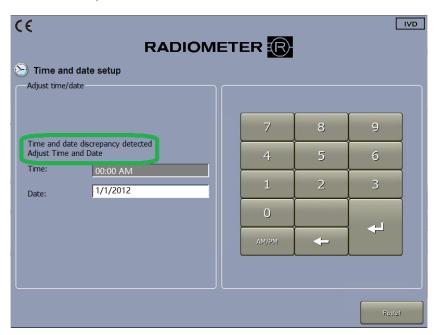
The software update ensures that the analyzer will detect any date and time discrepancy that may appear during a startup following an abrupt power break. When detected the analyzer will:

Time and date discrepancy detected Adjust Time and Date

The operator must then adjust time and date and touch Restart to confirm and restart the analyzer.

If the analyzer shows the above screen during startup then adjust the time and date.
