MCC/23/002/IU: Open service ports for Flow Family Anesthesia systems

Description of the issue

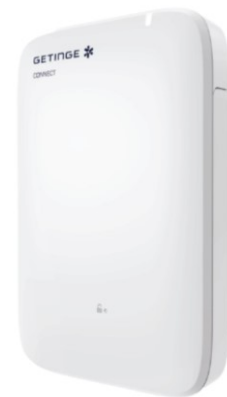
Getinge Connect module X10 / X20

If you have a Getinge Connect module (X10/X20) connected to the Ethernet port on the Flow Family Anesthesia system, no action is required.
