URGENT FIELD SAFETY NOTICE

RE: THUNDERBEAT Type S Hand Instruments

Olympus reference: QIL FY25-EMEA-26-FY25-009- Thunderbeat Jaw Breakage Issue

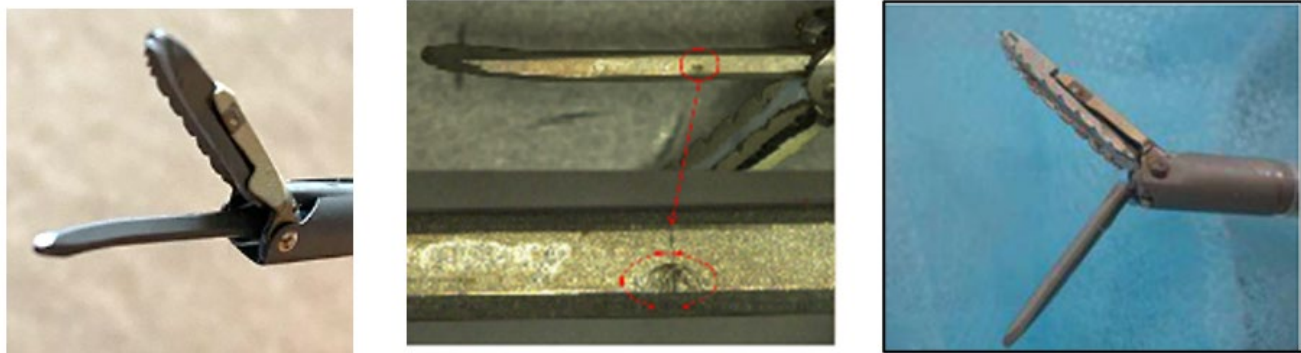
Olympus has been made aware, via customer feedback, of reports where probe tips of the THUNDERBEAT Type S Hand instrument are becoming damaged or are breaking (Reference example in Figure 1), as well as instances of pad damage or detachment (Reference example in Figure 2). These issues can occur when the instructions and warnings in the IFU are not followed, specifically, taking very large bites of tissue, contact with metal while activating, and activation without tissue between the jaws.

Figure 1. Example of Thunderbeat Probe in accordance with specifications (left), Cracked Probe (Center) and Probe Fracture (right)

In addition, Olympus strongly recommends the use of the ITM (Intelligent Tissue Monitoring) function to prevent probe pad damage due to over-activation, and therefore reduce the likelihood of probe tip damage. When using this function, the energy output automatically stops after the target tissue is divided. This is indicated by an audible signal/stop tone. Note: This function may need to be switched to 'on' on your generator, if not already enabled.

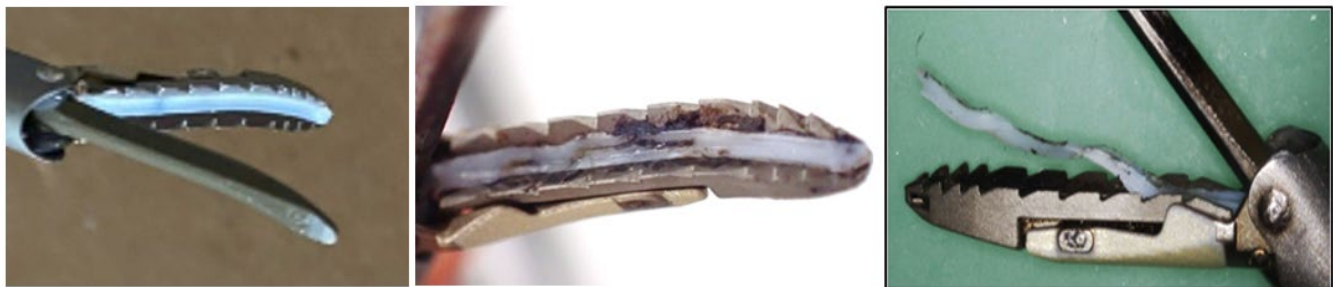
Figure 2. Example of Thunderbeat Probe in accordance with specifications (Left), Tissue Pad Deformation (Center), Tissue Pad Detachment (Right)
