FSN Ref: **FSN-2023-02**

Date: 30.03.2023

Field Safety Notice

Redon Bottle and Kölner Drainage of the manufacturer pfm medical mepro

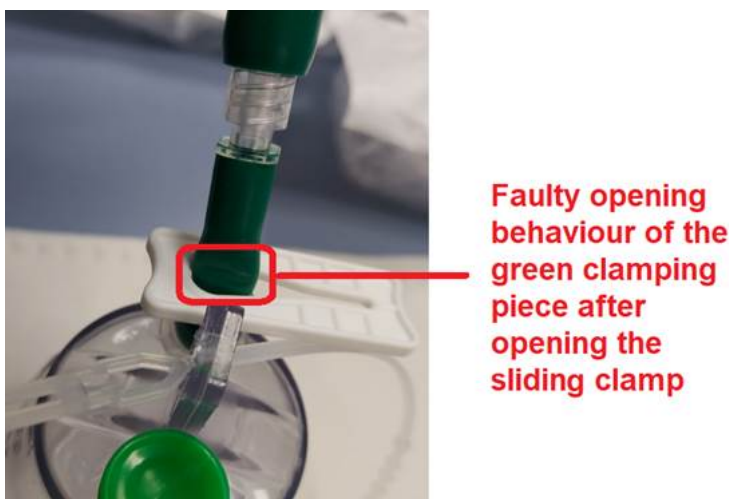
For articles from the affected batches, the opening behaviour of the green pinch-off piece on the bottle may be impaired (see illustration) because the material of the pinch-off piece sticks together slightly on the inside after opening. After opening the sliding clamp, this prevents the system from working properly and fulfilling its specified application purpose, the drainage of liquid.

Fig. Redon bottle with defective green clamp and sliding clamp

Following various customer complaints, the manufacturer has determined during the investigation of the facts that the opening behaviour of the green pinch-off piece may be impaired due to a material defect in the affected batches.

If the system does not work properly without being noticed, the patient may experience secondary symptoms such as pressure pain or shortness of breath.

- Inform all users and customers who have received affected batches;
- Return the products from the affected batches to us or destroy them;
- Document the activities on the FSN Response Form and return it to us.

To maintain patient care, the green pinch-off piece can be made common again by kneading the affected area.

The manufacturer has taken measures to prevent a recurrence of the defect. You will receive replacement goods for the returned or destroyed products.
