**URGENT SAFETY NOTICE, CAPTUS 4000E THYROID UPTAKE SYTEM****ACTION REQUIRED**

**Captus 4000e Serial Numbers 940548 through 941398 that have not replaced the arm in the last 24 months**

**Date Range: April 2019 through February 2024**

**Revised July 1, 2026 - Adding risk of spring arm failure for high volume sites**

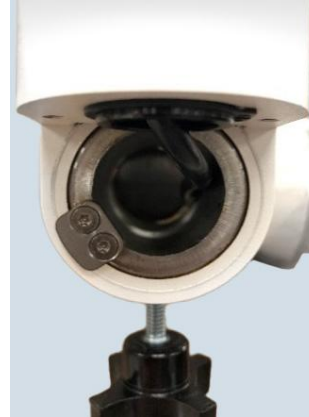
Figure 7: Front View

3.2. Visually inspect the two screws, identified in figure 4. The internal steel insert, brass liner and outer protective plastic cover should all be even, retention plate should be level, straight, and flush against the collimator, and the screws should level and flush with the retention plate. Figures 6, 7 and 8 show a properly assembled collimator.

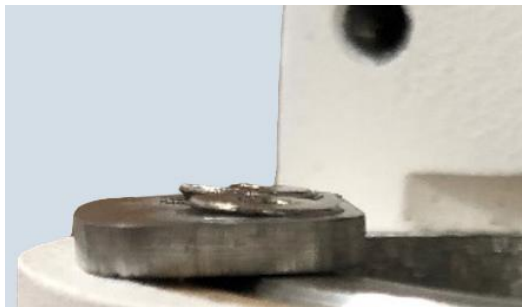
Figure 9: Example 1

3.3. Carefully inspect the area where the Pin Retention Plate is attached. Look for any signs that the screws are backing off or not flush, that the steel insert is raised and not even with the brass liner and outer protective cover, or that the retention plate is misaligned. Figures 9 and 10 show examples of a collimator which is not properly attached. Also note the screws may be either spanner screws from older models, or torx screws.

**NOTE: If the screws show any sign of backing off (not flush) or the steel insert is raised, immediately take the unit out of service and contact Capintec Technical Support.**
