## URGENT IMPORTANT FIELD SAFETY NOTIFICATION

| <b>Subject:</b> | Modulator Discharge Rod | |
| <b>Product:</b> | Digital Linear Accelerator | |

| Classification:    Important Field Safety Notification | FCO Reference Number:    200-01-103-089 |

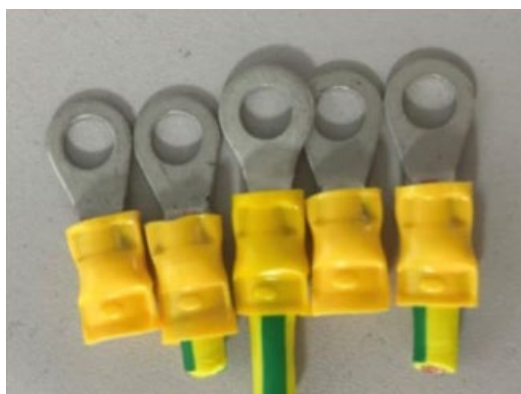
Elekta has identified a safety issue relating to the modulator discharge rod, where the supplier has been fitting the crimp in the crimp tool back to front. The issue was discovered during production.

The safety discharged rod earth lead has pulled out with ease which could lead to possible safety implications.

Figure 1 - Reverse Crimping

Elekta will release an Important Field Safety Modification (IFSM) to identify potentially faulty discharge rod crimping and provide further instructions. The IFSM will include procedures for verifying the reliability of the discharge rod crimping and replacing affected components if necessary

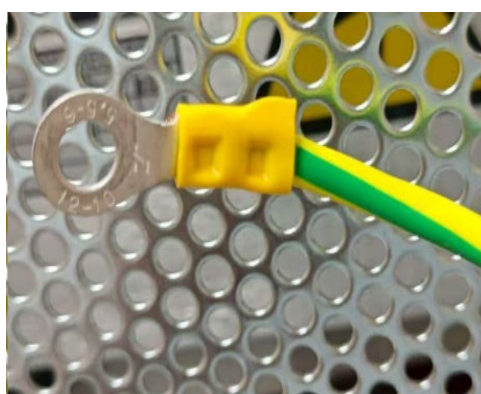
Not all crimps pull off easily, but stock has been found with crimps fitted in reverse.

Figure 2 – Wrong Crimping
