URGENT MEDICAL DEVICE CORRECTION

Model 1000 SenTiva[™] and Model 1000-D SenTiva Duo[™] VNS Therapy[™] Generators

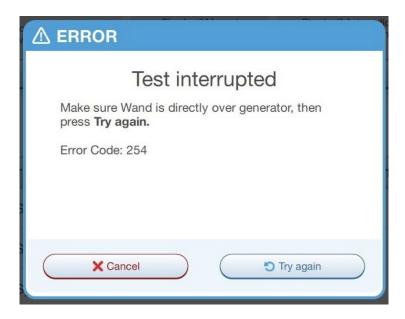
For all generators, perform an on-demand System Diagnostic test (using the Diagnostics tab in the programming software) at every clinic visit to confirm proper function of the generator. A generator with a reed switch stuck in the closed position will display "Error Code 254 – Test Interrupted" on a Model 3000 programmer when a diagnostic test is attempted using the VNS Therapy Programming System (see Figure 1).

Figure 1: "Error Code 254 – Test Interrupted" message encountered during System Diagnostic Testing

- 1. Monitor the patient for changes in clinical symptoms or if the patient loses perception of stimulation (e.g., the typical cadence for patient visits range from every 3-12 months). Perform an on-demand System Diagnostic test at each visit in accordance with the device labeling. Note that the diagnostic test that is performed as a part of the initial interrogation to enter a session will NOT detect this event. Information and recommendations regarding device checks and monitoring of clinical symptoms can be found in the VNS Therapy Physician's Manual. Access your approved labeling from the LivaNova VNS Therapy website or contact LivaNova for assistance.

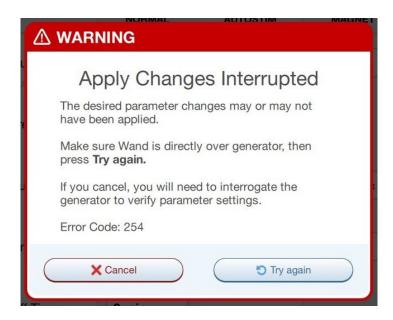
A generator with a reed switch stuck in the closed position may also prevent parameter changes from being made with the programming system. The programmer may display "Error Code 254 – Apply Changes Interrupted" (see Figure 2).

Figure 2: "Error Code 254 – Apply Changes Interrupted" message encountered during programming

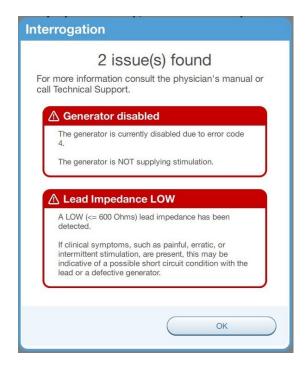
An on-demand System Diagnostic test may result in LOW lead impedance for some generators with a reed switch stuck in the closed position (see Figure 3).

Figure 3: Low lead impedance error message
