## URGENT FIELD SAFETY NOTICE

### RE: SINGLE USE LIGATING DEVICE POLYLOOP

| Material ID | Model Number | Material Description | Lot Numbers | UDI |
|---|---|---|---|---|
| N5382130 | HX-400U-30 | SINGLE USE LIGATING DEVICE POLYLOOP | See attachment | 04953170368615 |

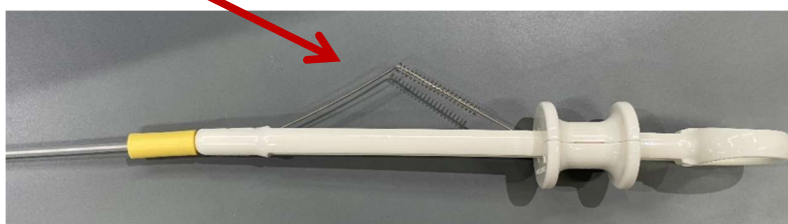
**Operation Pipe breaking**

Olympus is introducing a design change to address complaints that the ligation loop was unable to release or detach as expected during use, with operation pipe breakage being one of the contributing factors to these complaints. (see image below).

**Olympus requests that customers replace older versions of the device with the new design and return them to Olympus (refer to Attachment 1). Additionally, Olympus is reminding customers to follow the updated IFU.**

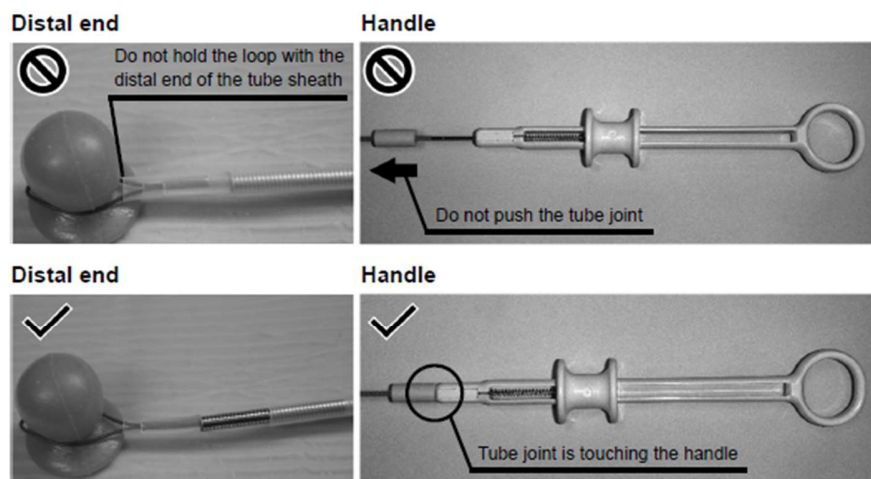
■ **Do not hold the loop with the distal end of the tube sheath while the loop is surrounding the tissue. (refer to page 5 in the manual)**

Otherwise, when the tissue is ligated, the loop may be detached from the hook in the tube sheath and tangled with the hook.

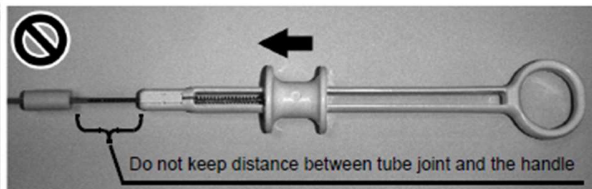
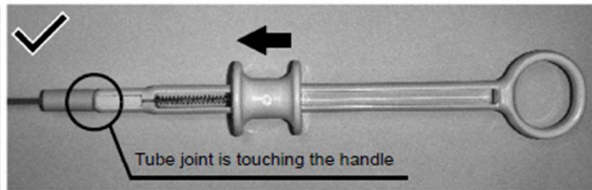
- **Do not remove the loop from the hook while the coil sheath is not extended from the tube sheath. (refer to page 6 in the manual)**

Otherwise, the loop may be tangled with the hook and become impossible to be removed.

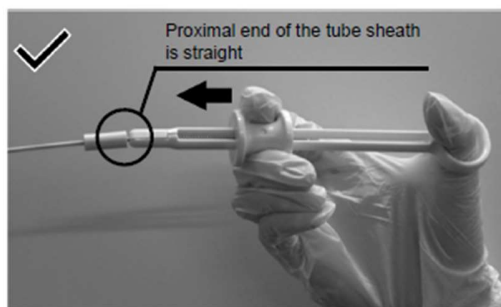
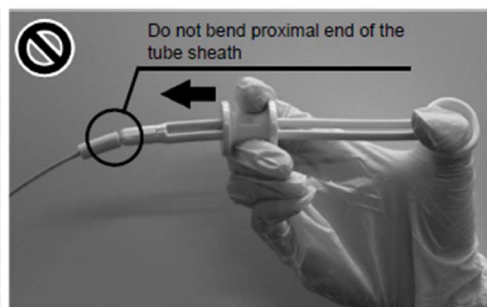
- **With the proximal end of the tube sheath and handle kept straight against the biopsy valve of the endoscope, push the slider when detaching the loop. (refer to page 6 in the manual)**

Bending the proximal end of the tube sheath will increase frictional resistance, which may damage the handle when pushing the slider.
