Cressier, 2019 June 11

Urgent: Field Safety Notice / FSCA 004-19

| Product name | ID number | Reference number | Lots numbers |
|---|---|--|---|
| DiaClon Rh-Subgroups + K | 50110 | 002124 / 002127 / 002126 / 002125 | All lot numbers until further notice |

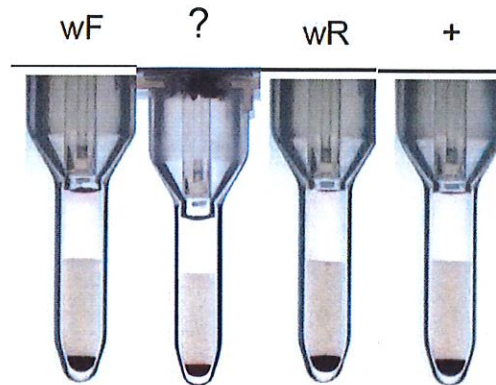
Further to customer's reports, we have been able to confirm that interference can be observed in the anti-e microtube with QC samples antigen e negative (RH:-5)

This interference is giving a pinkish color in the anti-e microtube with QC samples antigen e negative (RH:-5), the instruments may read it as wR, wF, ? or in extreme case as +.

And below some examples of interferences that led to incorrect grading by the instrument:

This situation may potentially lead to false positive results with QC samples antigen e negative (RH:-5).

- Repeat the QC test once, or,
- Edit the result and correct it as negative as long as the result fits with a negative reaction (refer to interpretation chart above).

If the issue remains, the ID-cards listed below may be used in replacement:

- DiaClon Rh + K Pheno II (Id-n° 50710)
- RhD + Phenotype (Id-n° 50130)

Product modifications are being studied in order to limit this interference in DiaClon Rh-Subgroups + K as quickly as possible.
