exocad

This Field Safety Notice (FSN) contains important customer information for patient safety and for the safe use of *exoplan*, our software for implant planning and surgical guide design.

<u>Field Safety Notice #</u> <u>322799 related to exoplan Argon Rapid Surgery Sleeve library</u> (affected part number 45009K3Pro.S)

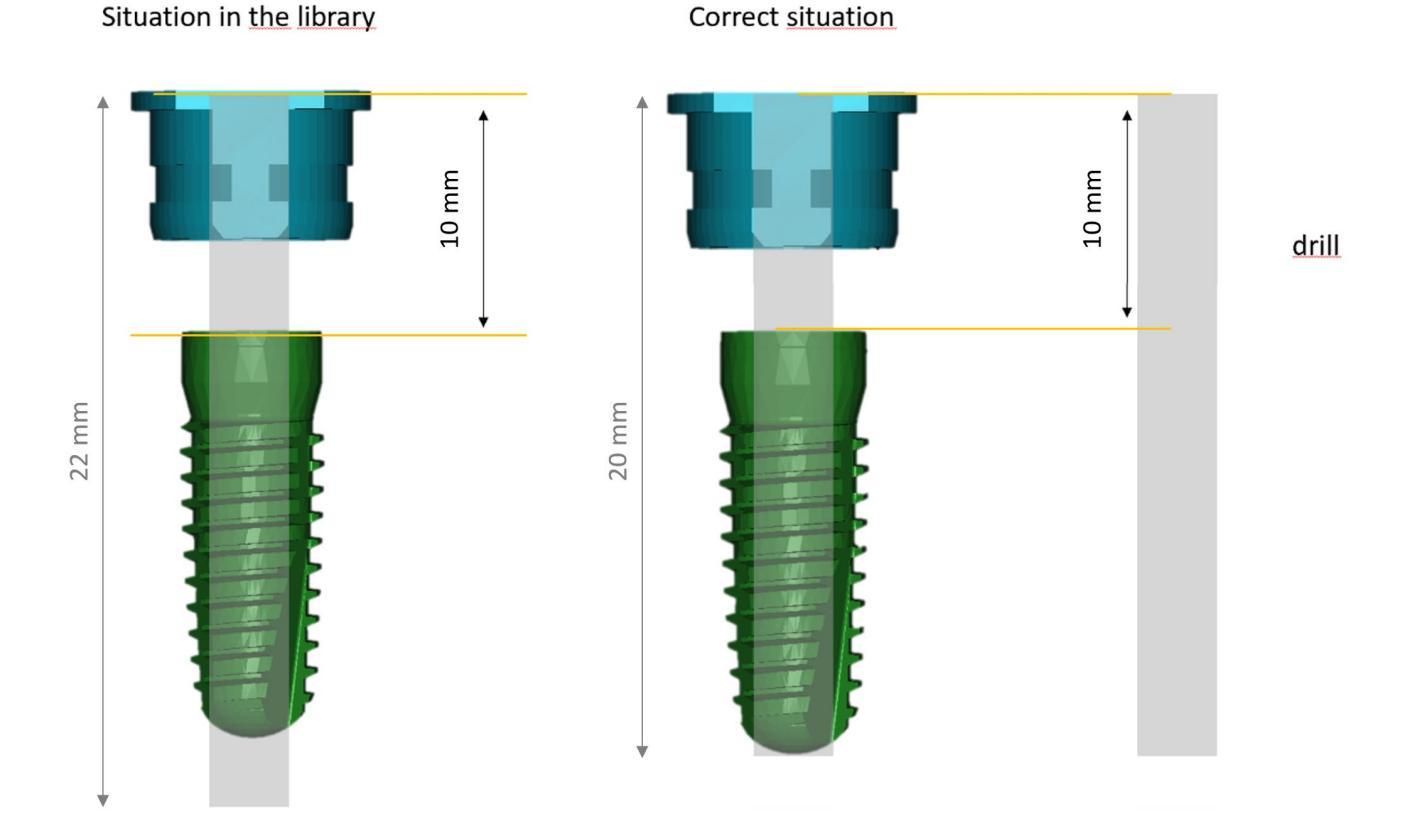
The issue is an incorrect specification in the Argon_Rapid_Surgery_sleeve libraries, suggesting the use of a surgical drill that results in a 2 mm deeper drill hole than expected due to a dimensional error in the affected libraries.

Figure 1: Sketch comparing the distance situation between sleeve, implant and drill for the wrongly entered drill (left) and the correct drill (right).

The identified issue in the Argon Sleeve Library, where incorrect drill length information is reported, poses significant risks to patient health during dental implant surgeries. Specifically, the software indicates a drill length that is 2 mm longer than necessary. The software provides a default safety margin of 1.5 mm, which as a result of the incorrect drill length information, is insufficient, as it is also shifted by 2 mm. This error can lead to over drilling beyond the intended surgical boundary.

- 4) New library version of Argon_Rapid_Surgery_sleeve have been released (<SignatureDate>2024-05-07T14:47:36.6611068Z</SignatureDate>). Users can now download and install the new libraries.

- 1) Do not use the affected libraries see section "Affected libraries" above.
- 2) Download the new libraries at <u>https://exocad.com/integration/exoplan-library-integration</u> or use exocad *Library Manager* from within *exoplan*.
