Cressier, 22nd December 2020

Field Safety Corrective Action / FSCA 004-20

Description of the problem:

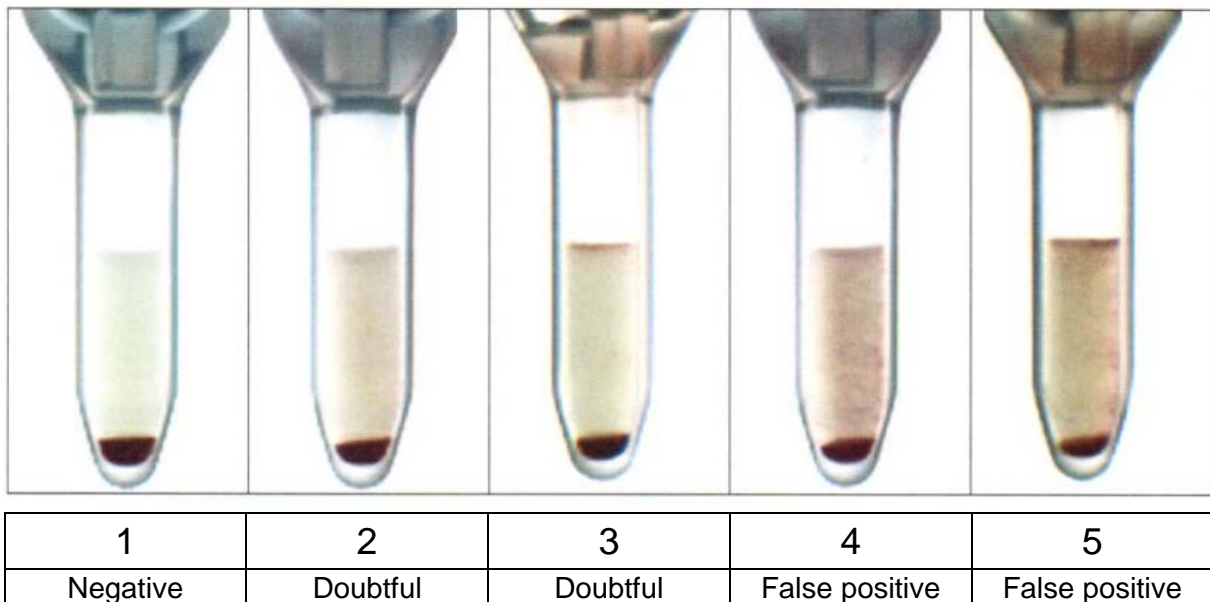
The root cause for both these phenomena is highly suspected to be related to the type of glass vials used in the manufacturing of reagent red blood cells.

The first phenomenon concerns nonspecific reactions primarily observed on QC samples but also with patient samples and eluates. Doubtful reactions or in some cases false positive reactions may occur randomly between batches and within a same batch. This phenomenon can appear with both manual and all automated methods.

The following are examples of the type of image that can be seen when the phenomenon occurs (image 1 in Figure 1 shows a normal negative reaction for comparison). These nonspecific reactions vary from doubtful (images 2 and 3) to positive (images 4 and 5) as shown in the figure 1 below.

Figure 1_Example of nonspecific reactions observed in IAT

The analyzer (Banjo ID-Reader, Saxo ID-Reader II, IH-1000, IH-500 or Classic ID-GelStation) may interpret a “?”, “wR”, “wF”, or “DP” (image 2 and 3 in Figure 1) or any option up to ++ (images 4 and 5 in Figure 1), depending on the intensity of the reaction.

In case you are facing the **nonspecific reaction** during the result validation (referring to figure 1), we recommend to:

1. Invalidate the result,
2. Repeat the test using non-open vials of the same lot,

3. Repeat the test with using a kit of a new lot,

4. Use an alternative method.

If you work with the automatic validation activated, we recommend the visual confirmation of all positive results of indirect antiglobulin tests.

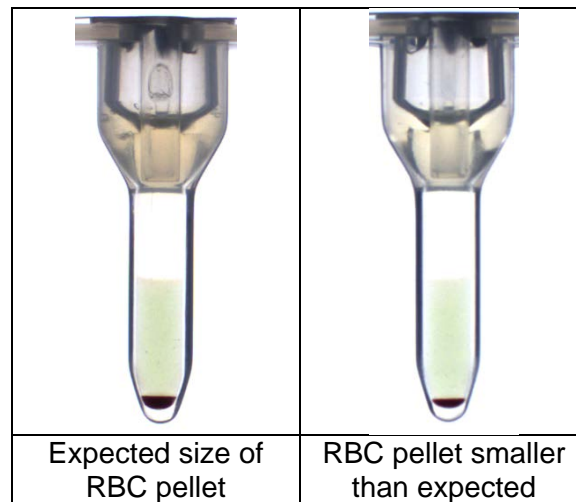
The second phenomenon concerns insufficient homogenization of the red blood cells within the vials when stored on-board either on the IH-500 or on the IH-1000 and when the remaining volume reaches 2ml or lower. This lack of homogenization can lead to a dispense of low-concentrated red blood cell reagent into the wells of the ID-cards.

The following are examples of the type of images (Figure 2) that can be seen with small pellet compared to a well with expected red blood cell amount.

Figure 2_Example of small pellet observed with insufficient red blood cell homogenization

The **insufficient homogenization** leading to smaller pellets in the microtube occurs when the remaining volume of the reagent in the vial decreases.

If you detect smaller pellet than expected during the result validation (referring to figure 2 or comparing with other available result), we recommend to:

1. Invalidate the result,
2. Unload the reagent, swirl it gently to homogenize the reagent and load it back in the instrument,
3. Repeat the test,

4. Retest with a non-open vial

To prevent this phenomenon, particularly if you are operating under the automatic validation of the results, we recommend resuspending manually the red blood cells at least every hour by gently swirling the vials, when the remaining volume has reached 2 mL or lower.
