Urgent Field Safety Notice **Moviplan 800**

Urgent Field Safety Notice (FSN)
Moviplan 800
Risk addressed by FSN

N. NIM003-2021
Date: *November 3, 2021*
Subject: *Pin soldering verification*
To: *Villa dealers*
Equipment: Moviplan 800

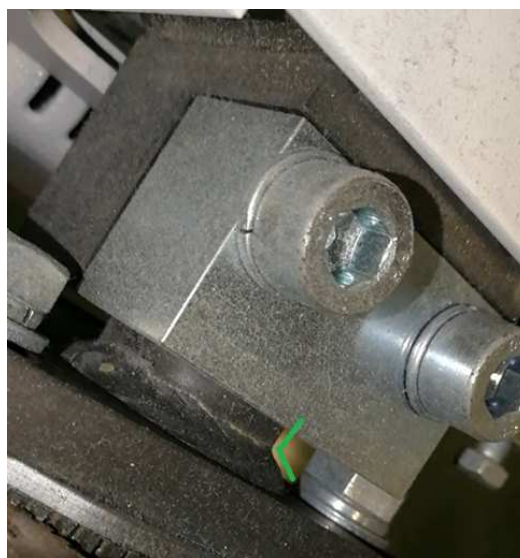
Just for reference, here following the type of verification to be done in field on installed units, where it is visible, without dismounting x-ray tube, the difference between correct welding, that should have the weld throat size of about 4mm, and non compliant welding

In green you can see the correct weld throat size

With this Note, we inform you that the some tube support shaft mounted on Moviplan 800 columns manufactured between April 2020 and March 2021 could have a non compliant welding due to the dimension of the welding throat.
In case you find this type of welding, it is required the tube support replacement.

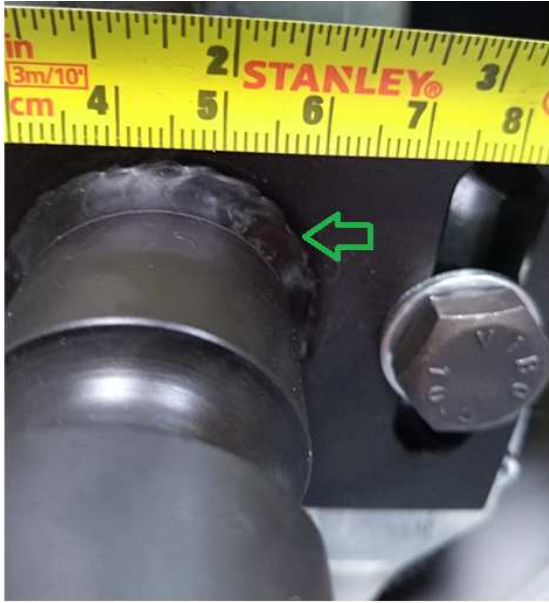
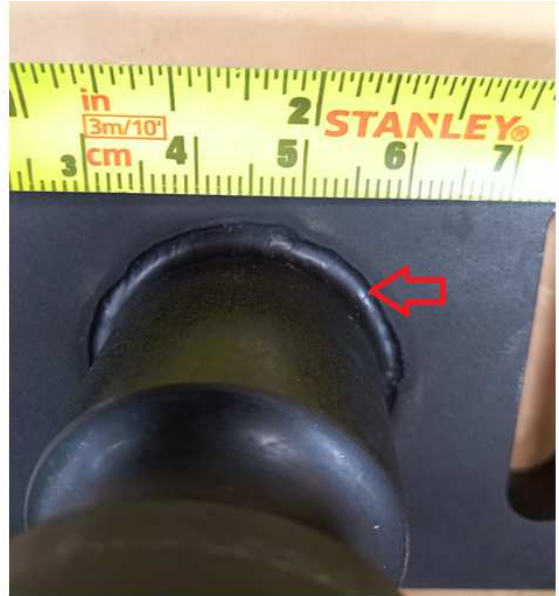
For better understanding, here following the differences between a correct welding (green arrow) and a non compliant welding (red arrow).

In case it is necessary the replacement, the spare part code is:

6174791100 Tube support for Moviplan 800 column

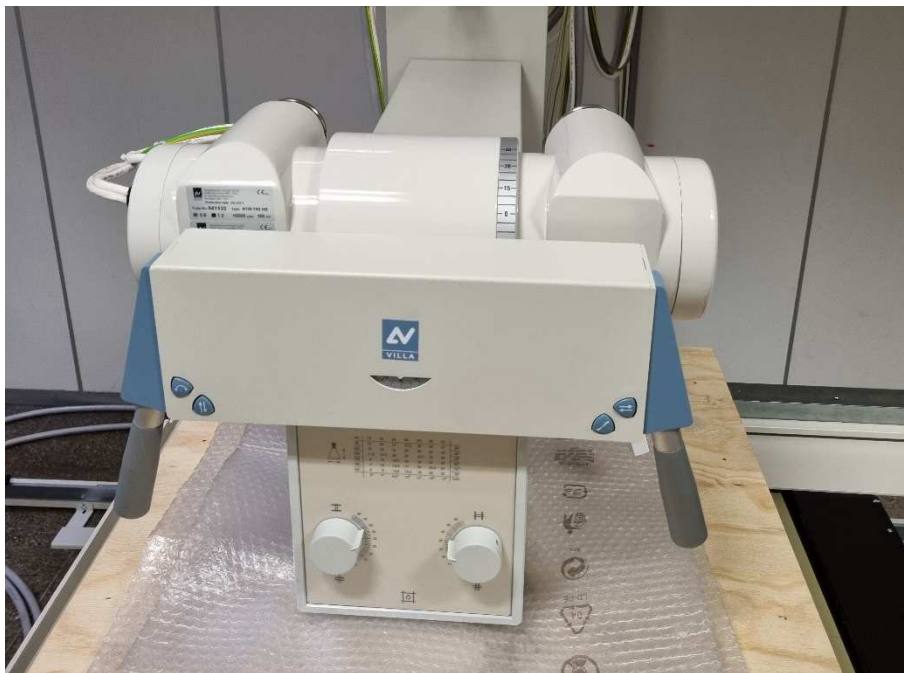
Position the column close to the table top centre in order to put on the tube group.
Protect table top surface in order to avoid scratches

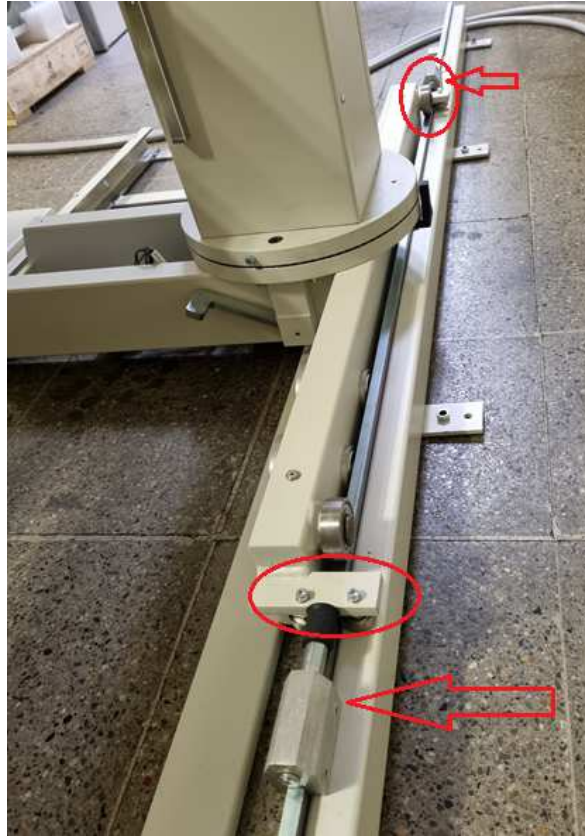
Move bumpers in both sides against the column frame to avoid longitudinal movement of the column during replacement

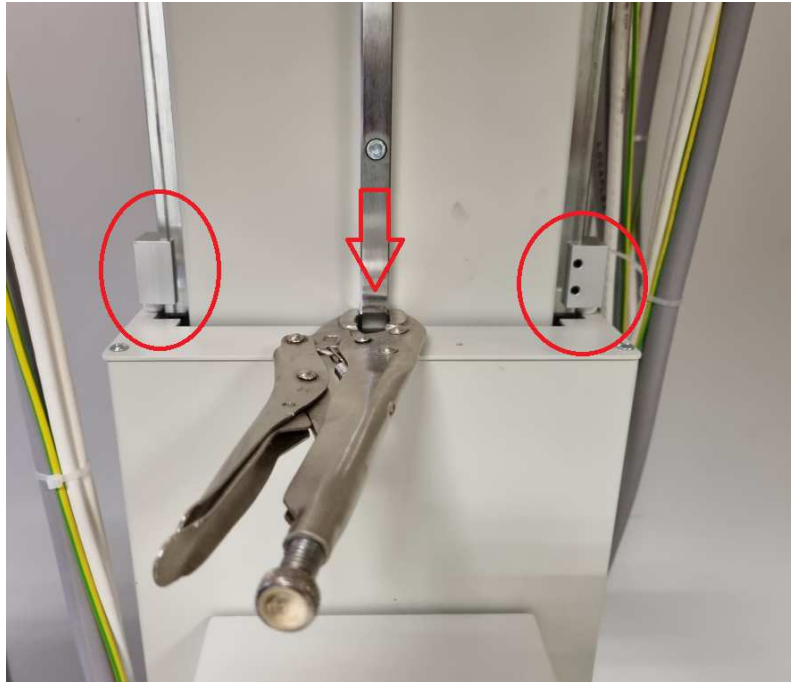
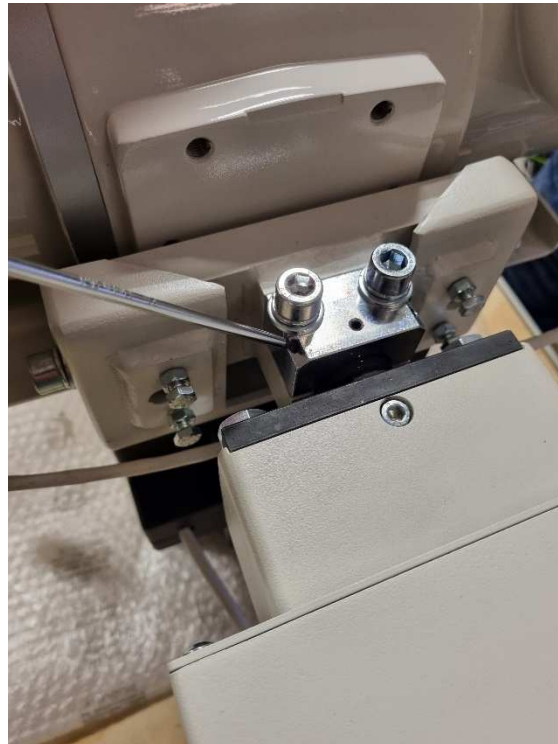
Position the collimator in touch with table top and fix cursor using a locker plier and moving end run bumpers against cursor

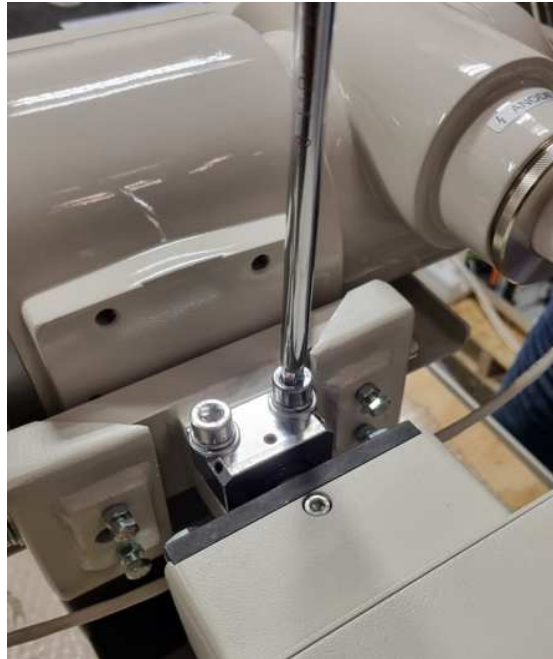
Remove the upper block screws

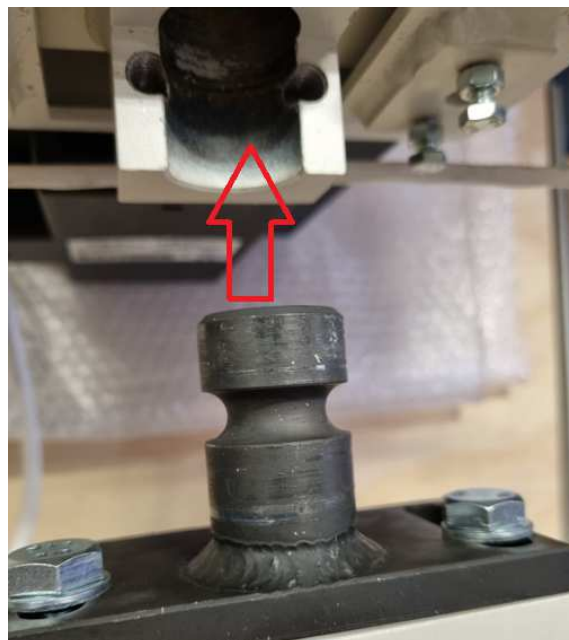
Pull out the tube group and leave it on the table top

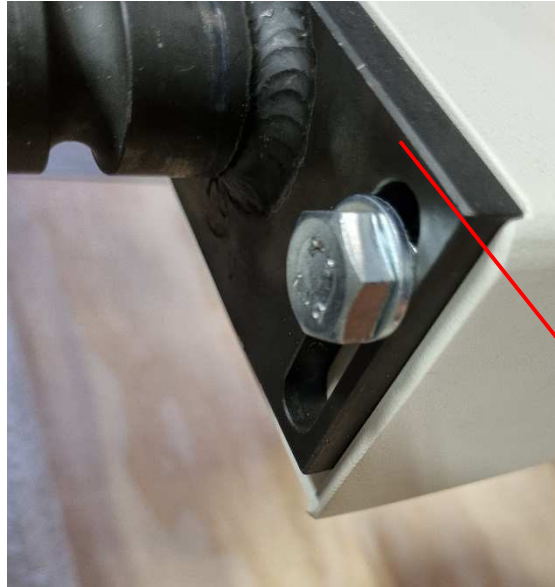
Take a reference of the actual pin position

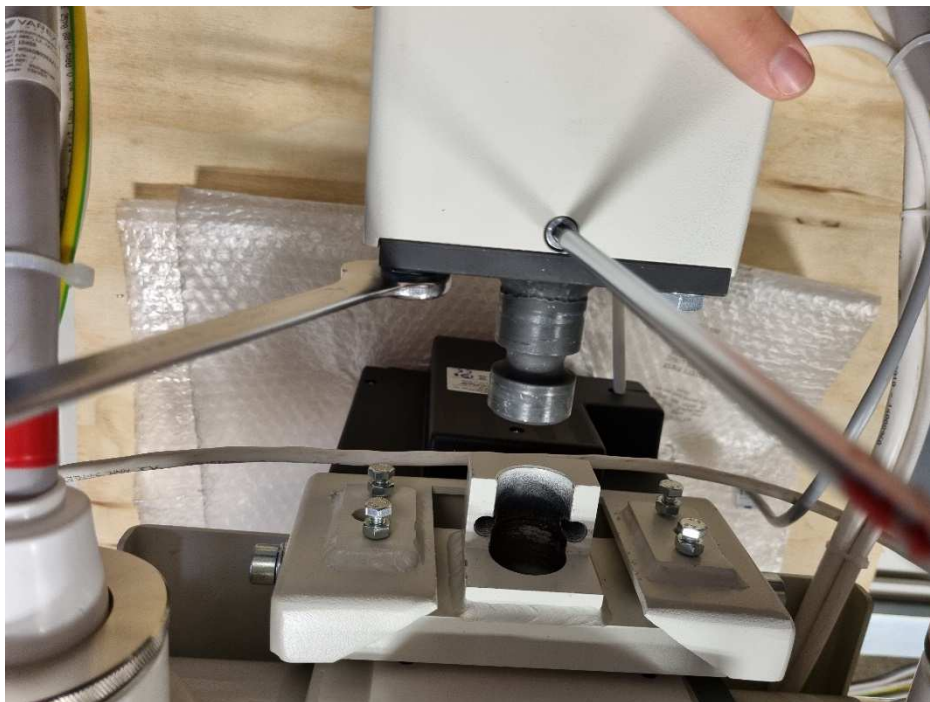
Remove the three fixing screws before the lateral ones, then the middle one

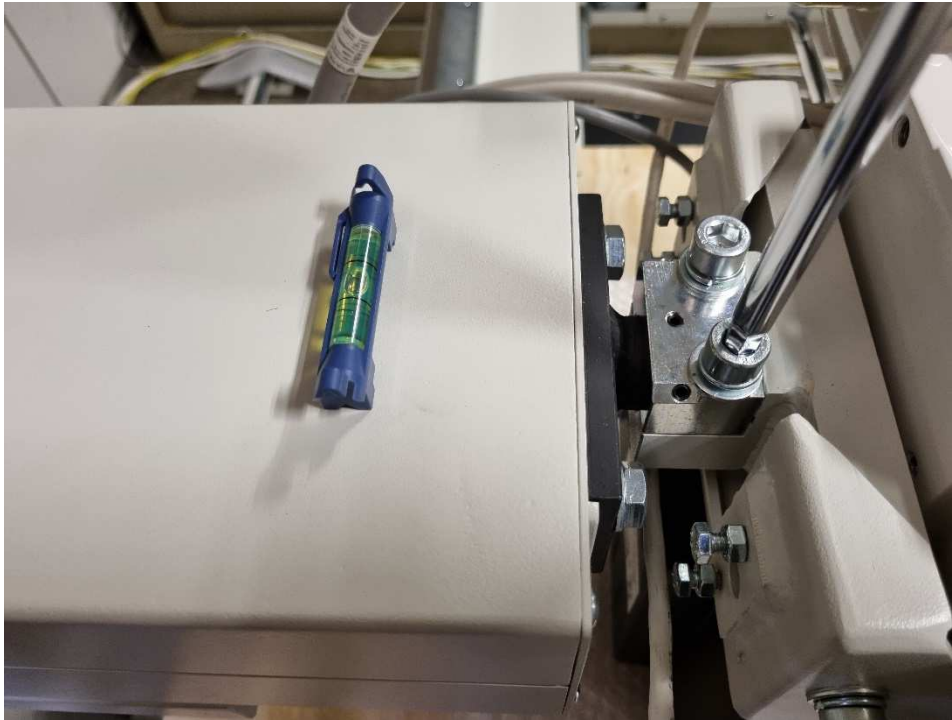
After pin replacement, mount the tube group, and verify if tube and column are at the same level using an air bubble. Fix the screws. Before fixing the grub screws, verify x-ray beam alignment

Release locking plier and reposition the end run bumpers on column and rails

Once verified the centering, fix the grub screws.
