Urgent Field Safety Notice

Title: Carbon fiber side guards with untrimmed edge

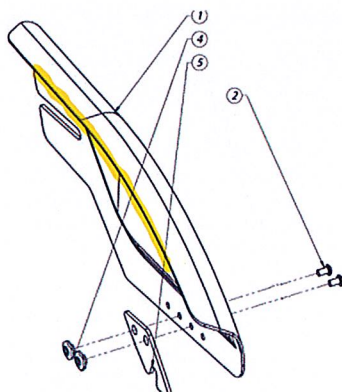
This Field Safety Notice (FSN) concerns carbon fiber side guards (table 1) distributed by Panthera AB between December 1, 2023, and March 15, 2024. The side guards have been found to potentially be untrimmed causing one of the edges to be sharp, see figure 1 for description of affected area. The investigation of the root cause concluded that the supplier of the side guards has not trimmed the edges correctly.

Figure 1. Edge of side guard that potentially can be untrimmed.

To identify if the edge is sharp, use the upper side of your thumbnail and gently slide from the inside out on the underside of the marked edge, see figure 1. If the edge is sharp, we recommend as an initial immediate action, that the sharp edge is taped either by you as a distributor or by the user. Then immediately contact Panthera, who will take permanent action to avoid risk to users.
