**URGENT:**  
**MEDICAL DEVICE SAFETY NOTICE: CUSTOMER NOTIFICATION**  
**Number: RA2024 - 3612746**

## Synchro® Guidewire

## Appendix A Synchro® Guidewire

### Backloading and How to Identify PTFE Coating Damage

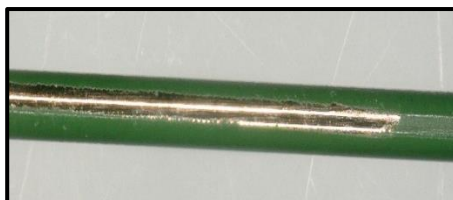
Figure 3: PTFE damage on the Synchro Guidewire

3. The optional introducer accessory provided with the Synchro Guidewire may have sharp edges. These sharp introducer edges may cause peeling of the PTFE coating if users backload the guidewire into the introducer. See Figure 2. The PTFE coating is colored, and the peeled coating is visible to the naked eye when damage occurs. See Figure 3.

- If damage to the PTFE coating is observed, follow the Instructions for Use (IFU) precaution, and do not use the damaged guidewire. Contact your Stryker Neurovascular representative for a replacement product.
