**Subject: URGENT - FIELD SAFETY NOTICE – INTEGRA – CUSA® Excel 23KHz Straight Handpiece – Reference: C2600 – FIELD SAFETY ACTION**

**Legal manufacturer:** Integra Lifesciences, IDA Business and Technology Park, Sragh Ave, Tullamore, Co. Offaly – IRELAND. IE-MF-000003849

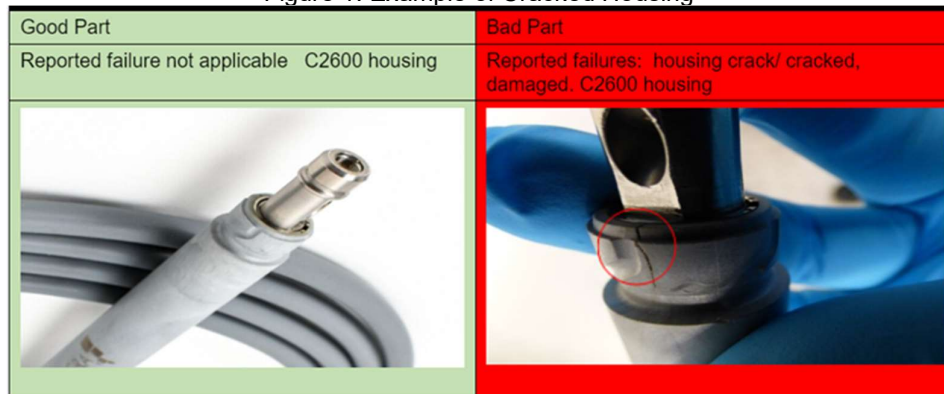
Figure 1: Example of Cracked Housing

The decision to conduct a voluntary correction of the product was based on the following: through an internal investigation of customer complaints, it was identified that there is a potential for the CUSA Excel 23KHz Handpiece housing to crack. In order to mitigate this issue, the devices will be reworked through our service and repair process for the units manufactured prior to November 2023.

2. The Handpiece cracked housing may be visually detected by clinical staff during inspections prior to or post-surgery. If a crack is noted, please remove the handpiece and return it for a free housing replacement.

7. The handpiece(s) should be returned to Integra S&R for service, email: TCS.Distributors@integralife.com, and there will be free replacement of the handpiece housing.

3. If a crack is not noted, Regardless of the service contract status, the housing will be replaced free of charge during your next service.
