Olympus reference: QIL FY23-EMEA-03

## URGENT FIELD SAFETY NOTICE

**FIELD SAFETY CORRECTIVE ACTION ON WM-NP3/WM-DP3 MOBILE WORKSTATIONS – POTENTIAL FOR INSUFFICIENT TRANSFORMER CONNECTION THAT COULD RESULT IN WORKSTATION SHUTTING DOWN.**

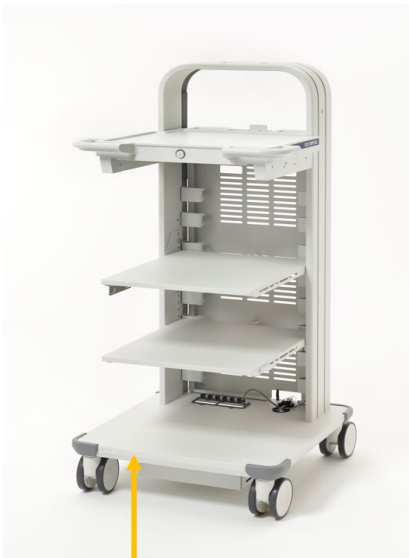
WM-NP3 MOBILE  
WORKSTATION

- An 8-digit serial number is located on the left-hand side of the bottom shelf. The serial number is a part of a digital barcode.
- Note: Serial number is the last 8 digits of a longer numerical barcode.
