FIELD CORRECTIVE ACTION NOTICE

Leica M525 F20 Microscope System

FCA Identifier: CAPA-HER-MD-18-001

Enhancement of instructions for use and additional markings to prevent inadvertent tipping

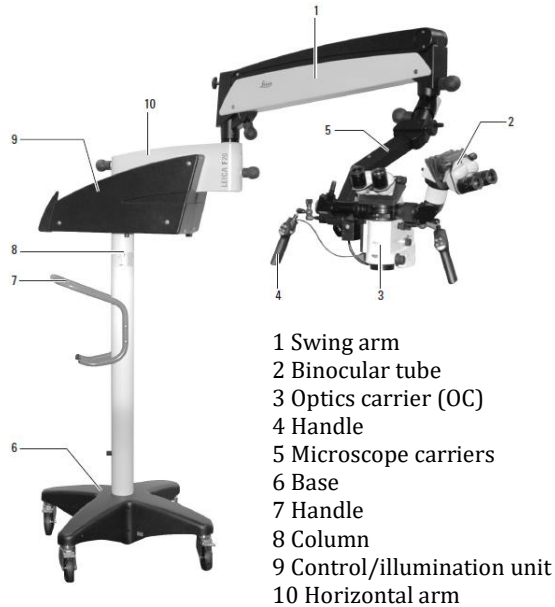
Figure 1: Overall view of Leica M525 F20 Microscope

This letter is to inform you about a field corrective action involving all Leica M525 F20 Microscope Systems (see Figure 1) to replace the instructions for use with an enhanced revision and to fix additional markings onto the device.

Leica Microsystems received five customer complaints stating that users inadvertently tipped over their Leica M525 F20 Microscope System. In four cases it was confirmed, that the issue occurred when users handled the microscope while the swing arm was in fully extended position (see Figure 3). In all cases the Leica M525 F20 did not cause or contribute to serious injury. The five complaints occurred in five different countries over a timeframe between the years 2010 and 2017. The Leica M525 F20 was introduced in the year 2009 with more than 1000 instruments distributed globally up to date.

Leica Microsystems identified an area of improvement in the instructions for use and markings as root cause for the reported issues. The existing instructions for use and markings on the device need to be elaborated in an enhanced manner to ensure all users will position and handle the Leica M525 F20 as intended with an angle of approximately 90° between horizontal arm and swing arm (see Figure 2). When the Leica M525 F20 is positioned with an angle of approximately 90° between horizontal arm and swing arm it is unlikely that the instrument is inadvertently tipped over by a person handling the instrument.
