## **IMPORTANT FIELD SAFETY NOTICE**

CentriMag™ Acute Circulatory Support System Motor Model: 201-10002  
*Compatible with CentriMag™ Pump and PediVas™ Pump*

September 5, 2018

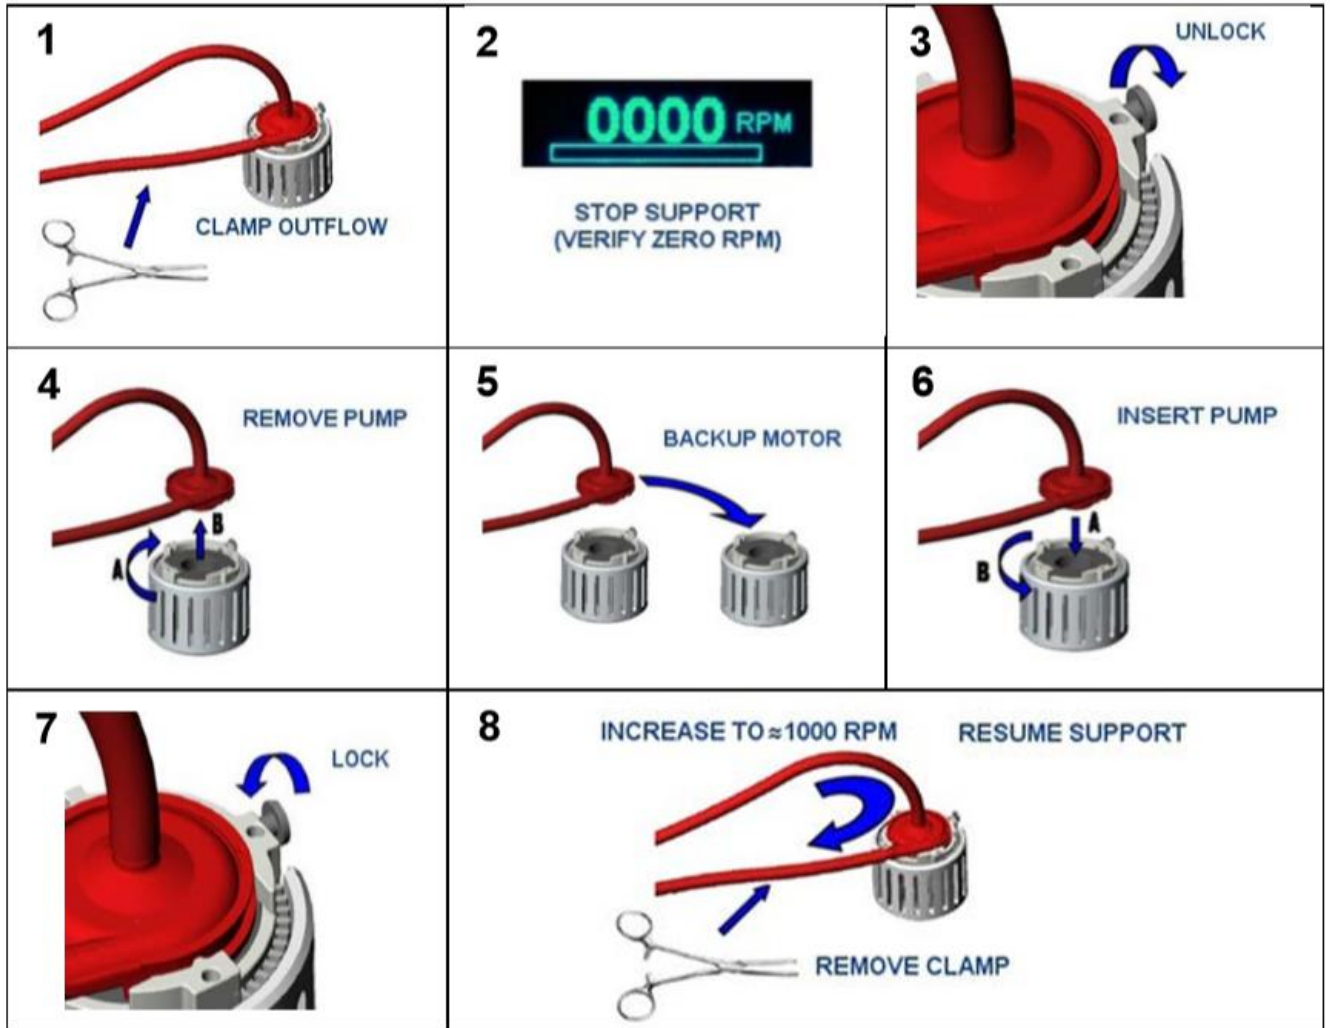
- Graphic regarding cable handling in the relevant CentriMag Circulatory Support System Operating Manual demonstrating the proper steps from transitioning a pump between the primary and backup systems.

- A full backup system must be in the immediate vicinity of every patient supported by the CentriMag System.
- Exchange the pump to the backup system as described in the CentriMag System Operating Manual and in Appendix 2. Improperly exchanging the motor to a backup console only could cause damage.
- Inspection of the CentriMag Motor, including the cable, for damage should be conducted prior to use. Do not use if damaged. If the cable is damaged and not visible as part of the inspection, the console will alarm during the procedure. Further detail about the visual inspection can be found in Appendix 3.

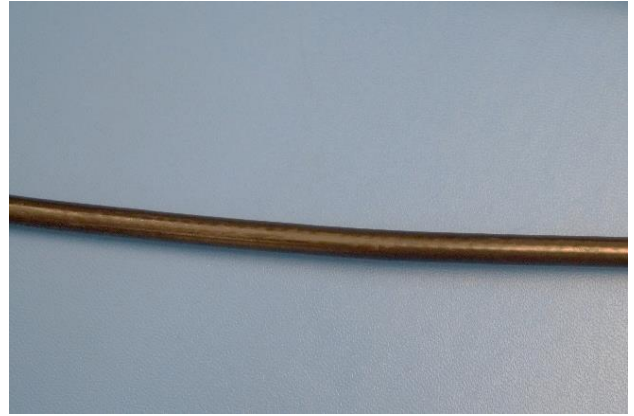
**Figure 6: Undamaged and Intact Motor Cable**

2. Visually inspect the entire length of the CentriMag Motor cable, including both bend reliefs (see Figures 3 and 4), for any damage such as separations of the bend reliefs, deformations, kinks, or cuts. These types of damage indicate wear and tear or previous rough handling of the cable, which has the potential to result in internal wire damage. Cable thickness and shape should be uniform throughout the length of the cable.

Before each use, verify that the cable connecting the Motor to the Console is not kinked, which can occur with improper handling such as wrapping the cable tightly around the Motor. If the cable is kinked, replace the Motor.
