Cressier, 2019 June 11

Urgent: Field Safety Notice / FSCA 004-19

| Product name | ID number | Reference number | Lots numbers |
|---|---|--|---|
| DiaClon Rh-Subgroups + K | 50110 | 002124 / 002127 / 002126 / 002125 | All lot numbers until further notice |

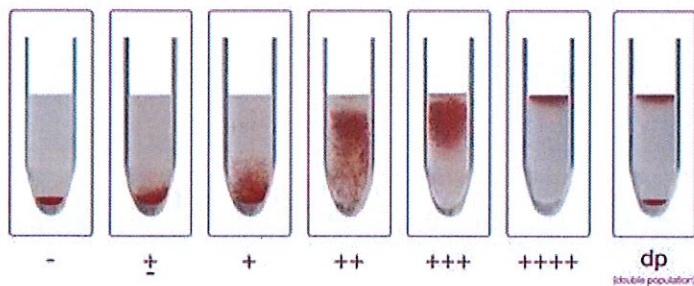
This interference is giving a pinkish color in the anti-e microtube with QC samples antigen e negative (RH:-5), the instruments may read it as wR, wF, ? or in extreme case as +.

As a reminder, hereunder is the reaction interpretation chart for the ID-System:

- Repeat the QC test once, or,
- Edit the result and correct it as negative as long as the result fits with a negative reaction (refer to interpretation chart above).
