**URGENT SAFETY NOTICE, CAPTUS 4000E THYROID UPTAKE SYTEM****ACTION REQUIRED**

**Captus 4000e Serial Numbers 940548 through 941398 that have not replaced the arm in the last 24 months**

**Date Range: April 2019 through February 2024**

**Revised July 1, 2026 - Adding risk of spring arm failure for high volume sites**

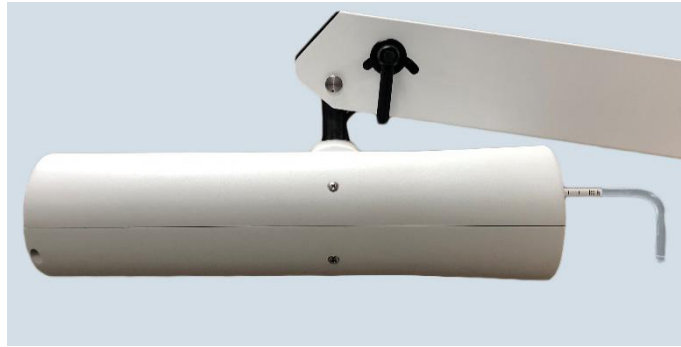
*Figure 2: Collimator Positioning*

1. Turn the Collimator to the horizontal position as indicated in figure 1.

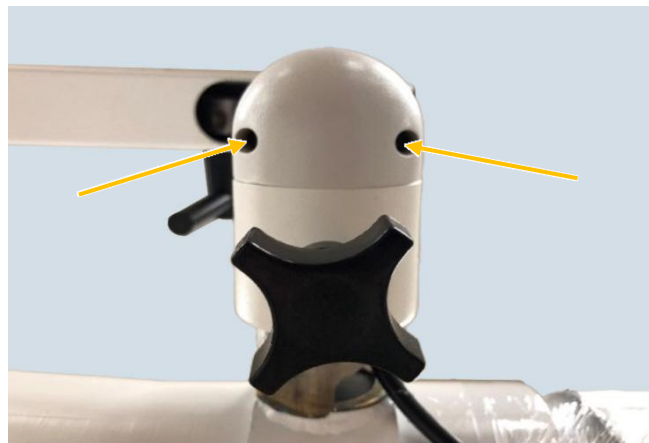
*Figure 3: Cable Cover*

2. Using a 3/32 Allen Wrench (Allen Key, Hex Key) remove the two screws holding the Cable Cover, shown in figure 2, in place. Counterclockwise motion of the Allen Wrench will loosen the screws, while clockwise motion will tighten the screws. Care should be taken to hold the housing in place until both screws are removed. Please note that the Allen wrench needs to be at least 2 inches in length to reach the screw head. Remove the Cable Cover to access the Collimator Block Assembly.

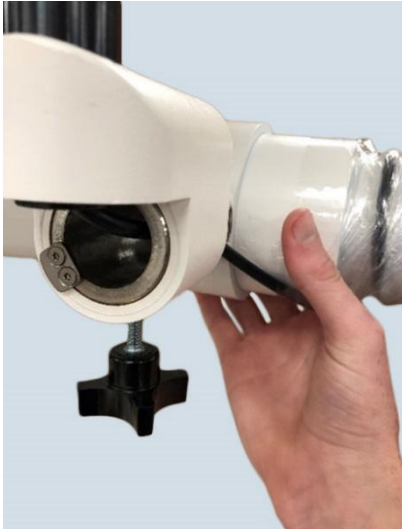
Figure 11: Hand Support Positioning

4. Next, check whether or not the retention plate is loose and can move. With one hand grab the Collimator as indicated in figure 11 and with the other hand gently attempt to move the Pin Retention Plate in the modes indicated in figures 12 and 13 below.

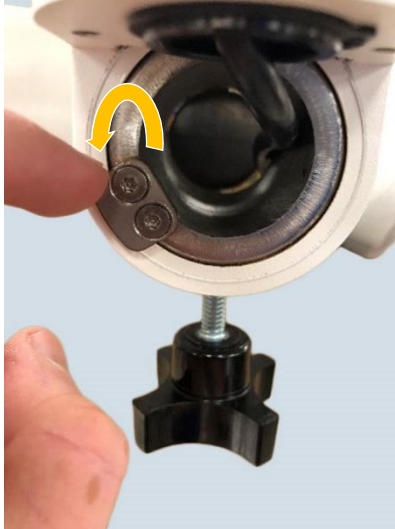
Figure 12: Movement 1

- 4.1. If you do not believe that you can fully support the collimator with one hand, get someone to help you. The retention plate on a properly attached collimator should feel snug and should not move when pushed gently with one finger. Do not try to forcibly move the plate or use a tool to try and move it. **Note: If the plate is loose and moves with gentle pressure immediately take the unit out of service and contact Capintec Technical Support.**
5. Document the status of your inspection with digital pictures and any comments noted below. If you are unsure about the status of your system, please send the pictures of the assembly to Capintec. Our technical support staff will review and advise you how to proceed. Please complete page 2 of this form and return together with any pictures and inspection comments to Capintec.

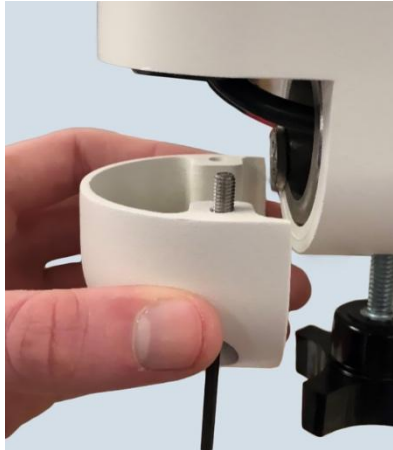
*Figure 14: Housing Re-Assembly*

6. Once the inspection has been completed, the back housing can be reattached to the collimator block assembly. Insert the first screw into the back housing as shown in figure 14, then move the housing to the collimator block assembly. Initially turn the screw counterclockwise until it is properly seated, then turn the Allen Wrench clockwise to tighten the screw. Insert the second screw into the housing assembly and fully tighten.
