## URGENT FIELD SAFETY NOTICE

### RE: SINGLE USE LIGATING DEVICE POLYLOOP

| Material ID | Model Number | Material Description | Lot Numbers | UDI |
|---|---|---|---|---|
| N5382130 | HX-400U-30 | SINGLE USE LIGATING DEVICE POLYLOOP | See attachment | 04953170368615 |

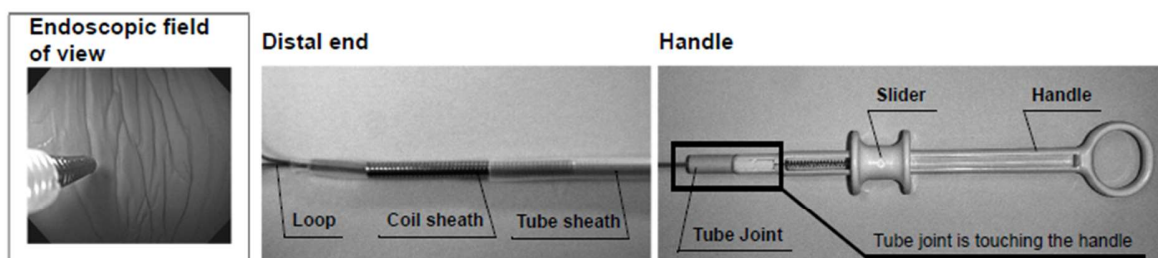
■ **Operation when ligating tissue (refer to page 6 in the manual)**

- Pull the tube joint until it touches the handle to extend the loop from the tube sheath.
- Confirm the endoscopic field of view to see that the coil sheath is extended from the distal end of the tube sheath.
